The Glitch & The Fix, May 2015

End of the line?

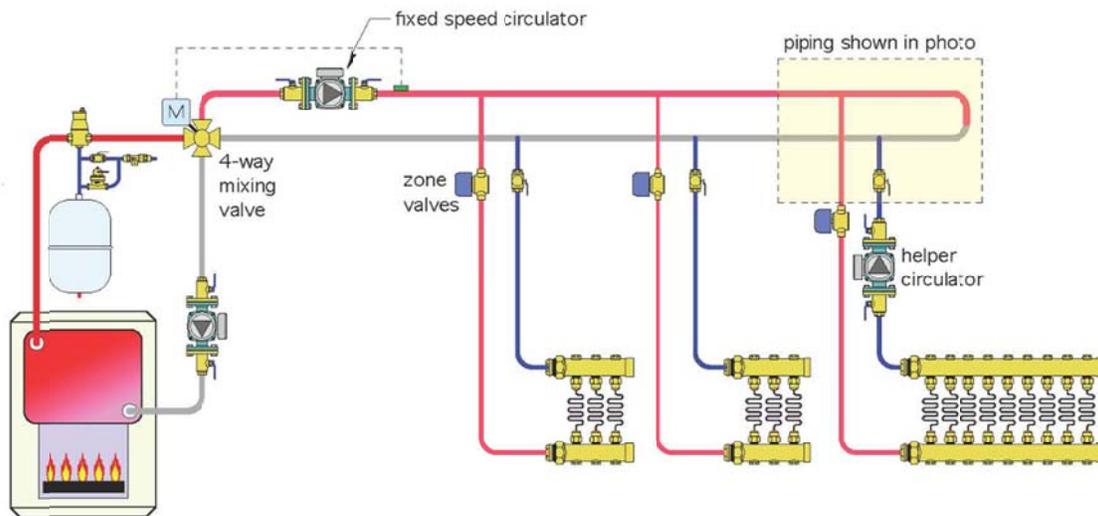
The piping in the photo shows part of the Glitch schematic. The piping to and from the two tees leads to a manifold station for radiant panel heating. One pipe is supply, the other is return. There is a “helper” circulator farther down the wall. The piping strapped to the bottom of the floor joists is supposedly part of a primary loop. The system is supplied by a low flow-resistance, cast-iron boiler. Water temperature is controlled by a motorized four-way mixing valve.

Although the installer probably thought he had created a primary loop, and even though those two tees are relatively close to each other, the take-off for the manifold station is not a secondary circuit. Neither are the other two circuits that serve the smaller manifolds. If the tees aren't right next to each other in the same pipe, it's not a secondary circuit.

When the far right circuit with the helper pump is operating, there is likely to be some flow reversal through the closed end of the primary loop. When water gets pushed out the end of a circulator, all it cares about is getting back to the other end of that circulator.

The shortest path for this is around the closed end of the piping loop at the far right of the schematic and photo. This will cause unintentional mixing. It also will affect the differential pressure driving flow through the other two manifold stations. The pressure drop around the closed end of the loop is likely to be quite low and, thus, there may not be sufficient differential pressure to drive adequate flow through the other two manifold stations.

The problem that will develop here is flow.

Think of it this way. If you were water being moved along the primary loop by the primary circulator and you could decide if you would rather go through those long radiant panel circuits, as well as the piping to and from the manifold station, or simply zip around the end of the loop seen at the right side of the photo, which would you choose?

Most (but not all) of the flow entering the tee just above the ball valve is just going to short-circuit around the end of this loop.

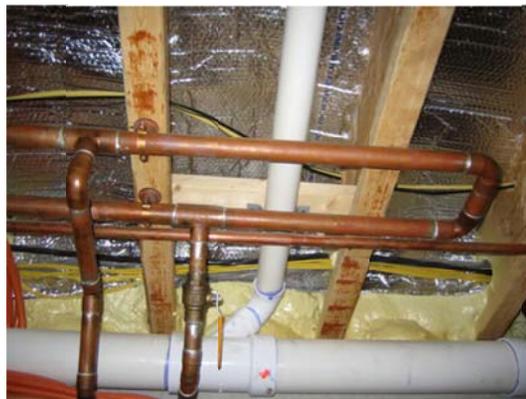
Other details that are missing or unnecessary include:

1. Boiler inlet water temperature sensor to the mixing valve controller, which helps prevent sustained flue gas condensation.
2. Purging valves on the return side of each manifold station circuit.
3. If the four-way mixing valve is close to the low flow-resistance boiler, there is no need of a circulator between this valve and the boiler.
