The Glitch & The Fix, Sept 2016
© Copyright 2016, J. Siegenthaler
First serial rights granted to BNP Media, all other rights reserved

Following Instructions...

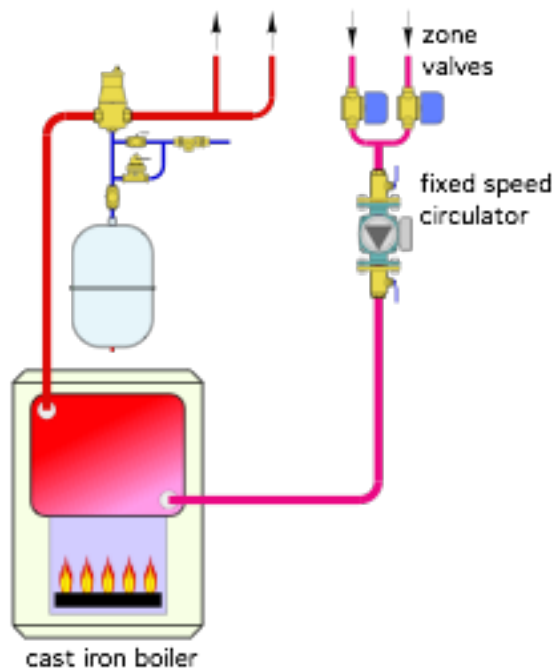
The schematic very similar to the one below appeared in a manufacturer's installation manual. It represented their recommendation for installing a two zone system. Can you identify at least five things that could be changed to improve this system?

1. The zone valves should be located on the supply side of the zone circuits to eliminate heat migration into inactive zone circuits.

2. The tee shown below the zone valves is a “bullhead” tee. When both zones are on, return flows slam directly into each other. This creates turbulence and noise. It also wastes circulator head.
3. There should be at least 12 diameters of straight pipe leading into the circulator. Placing it close to the side port of the bullhead tee allows turbulent flow into the circulator. This decreases circulator performance and creates noise.
4. The circulator in the glitch drawing is pumping *toward* rather than away from the expansion tank. This causes a decrease in pressure within the zone circuits when their circulators operate.
5. There is no provision for differential pressure control in the original system.
6. There are no purging valves in the original system.
