PM Dec 2018 Glitch & Fix

Sometimes Warm, Other Times Not So Much...

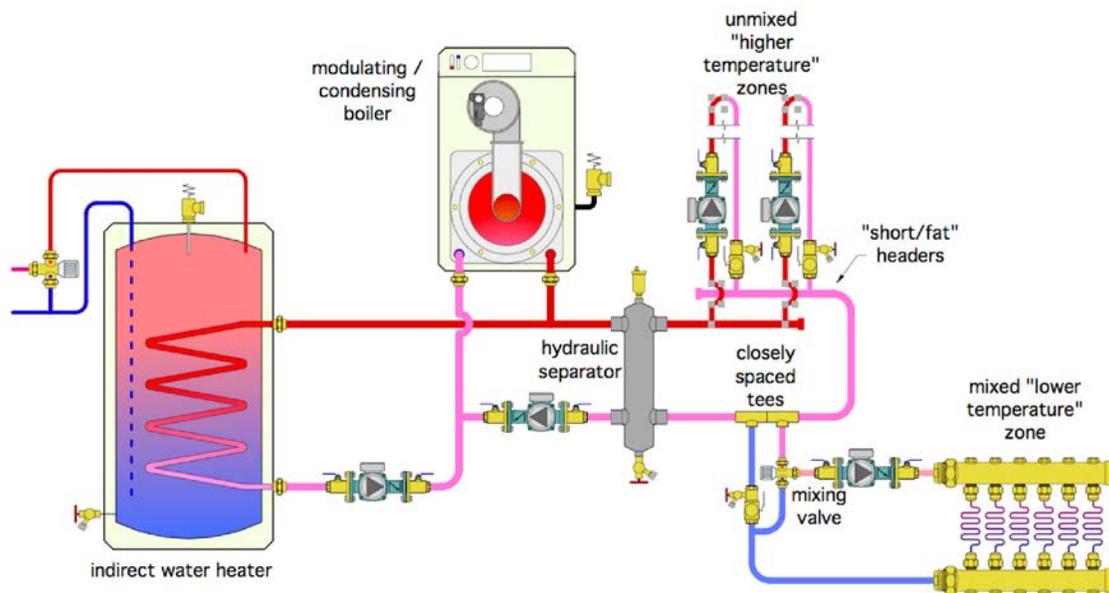
The Glitch: Eager to keep up with this new technology, an installer decides to install a hydraulic separator between a boiler and distribution system as shown below. The space heating loads consist of two “unmixed” zone circuits, and one mixed zone circuit. The installer connects the unmixed higher temperature loads upstream of the mixed lower temperature load. All the load circuits are supposed to operate independently. The indirect water heater is operated as a priority load.

When the system was turned on, there was very little warmth from the low temperature loads. What's the problem? Can you also spot a few more missing or incorrect details?

Using closely spaced tees downstream of the hydraulic separator adds a second unnecessary and undesirable hydraulic separation between the lower temperature “mixed” circuit and the hydraulic separator. The lower circuit will only receive heated water when the circuits connected across the header are active. At other times the water returning to the lower header will simply make a U-turn and be drawn back into the hot port of the mixing valve. The solution is simple: Pipe all the loads across the headers as shown in the fix drawing.
