ADVENTURES IN HYDRONICS HEATING

With Dave Yates ▶ **VOLUME 4**

2020 EXCLUSIVE QUARTERLY EBOOK SERIES

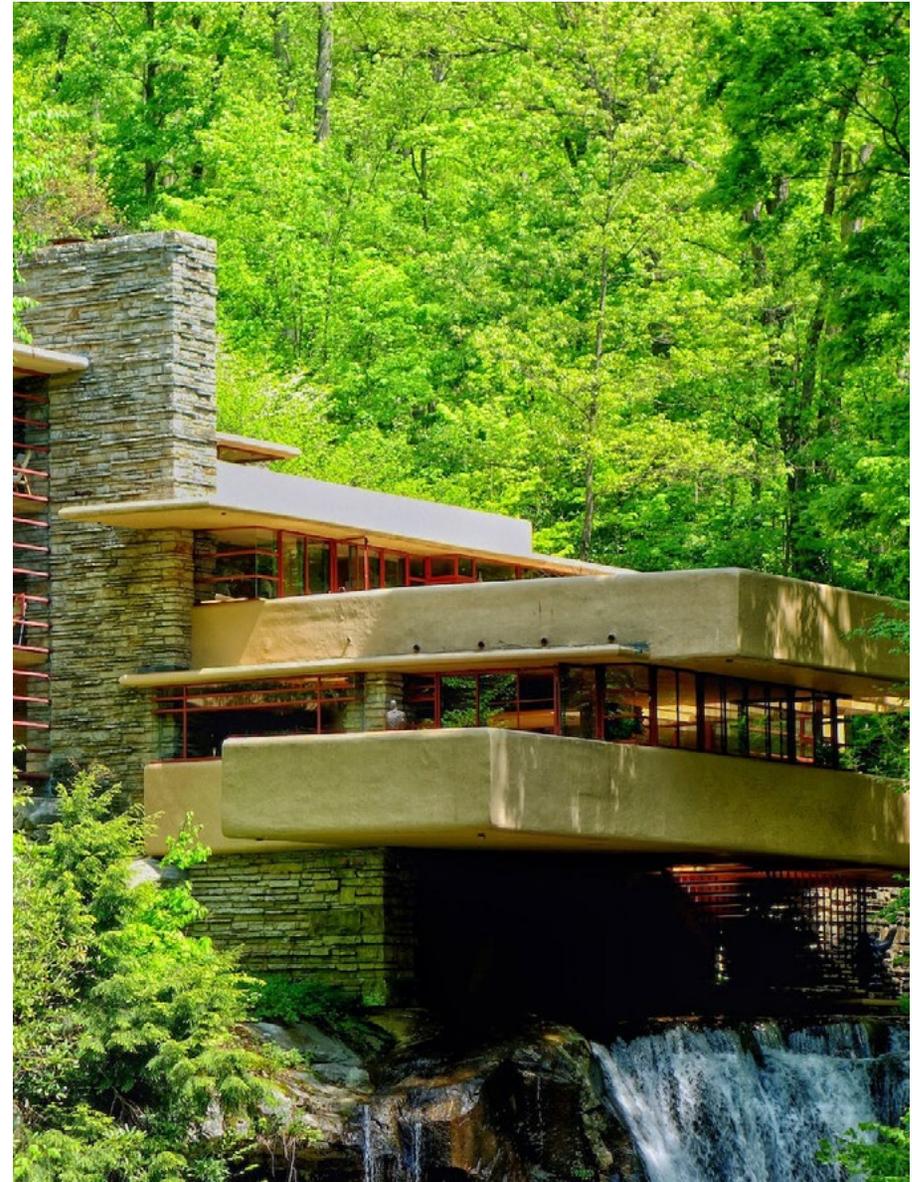
On July 20, 2000, the American Institute of Architects named Fallingwater as the Building of the Century. However, time and gravity had taken their toll on Fallingwater, and the home was imperiled. To prevent a potential collapse, steel supports were gently erected to carry the cantilevered construction’s weight until a permanent structural cure could be found that would not adversely impact Wright’s original design. A design was found that involves installing steel cables to counter-balance stresses placed on the cantilevered concrete beams in much the same way suspension bridges are built. In order to incorporate this design into the home, the stone floors had to be removed. When completed, every stone was returned to its original position and the home restored.

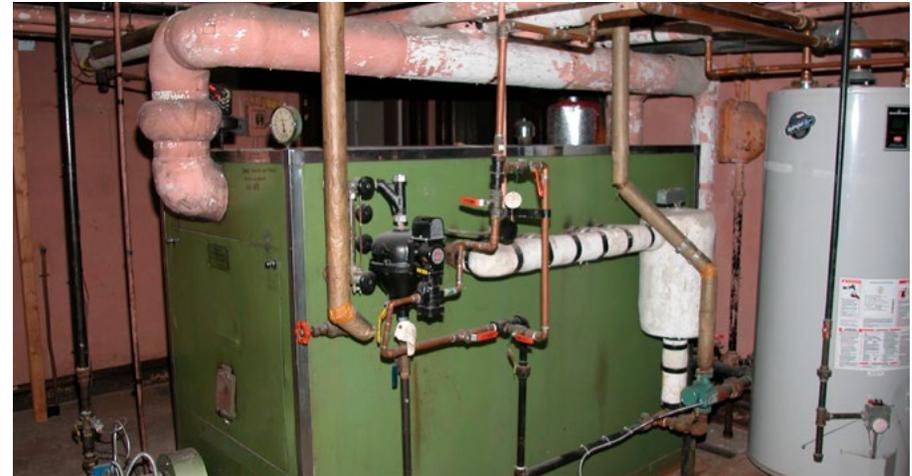
We were awarded the installation of a large commercial-sized cast iron steam boiler for a very large home built back when coal was king.

decades ago and condemned by the gas company for lack of combustion air. The existing steam boiler was, to put it kindly, grossly oversized.

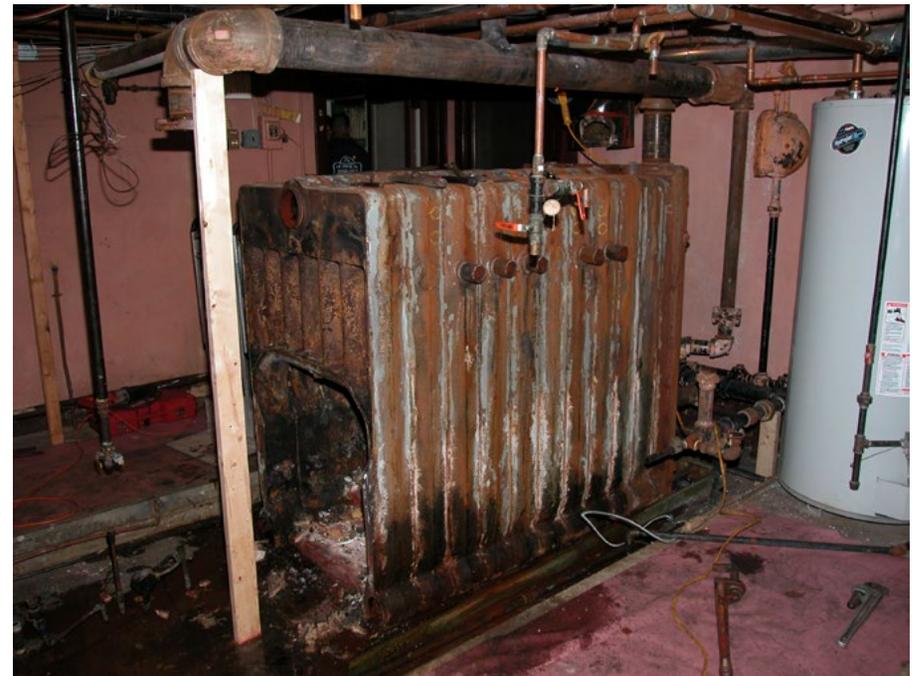
The existing boiler was grossly oversized.

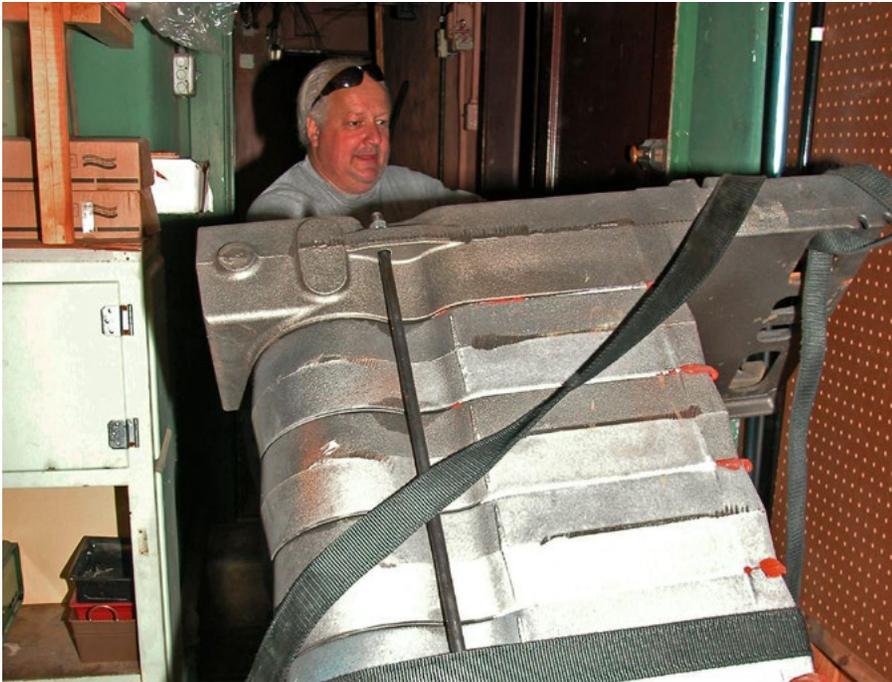
Les Scrivens of Thomas Somerville goes above and beyond while helping move the Weil McClain steam boiler into the mechanical room.

However, the sheer size and weight of this boiler caused concerns for everyone’s safety. So much so that we were visited at the home’s jobsite by several representatives who had serious doubts about attempting to move the boiler as a single block of factory-assembled cast iron. The

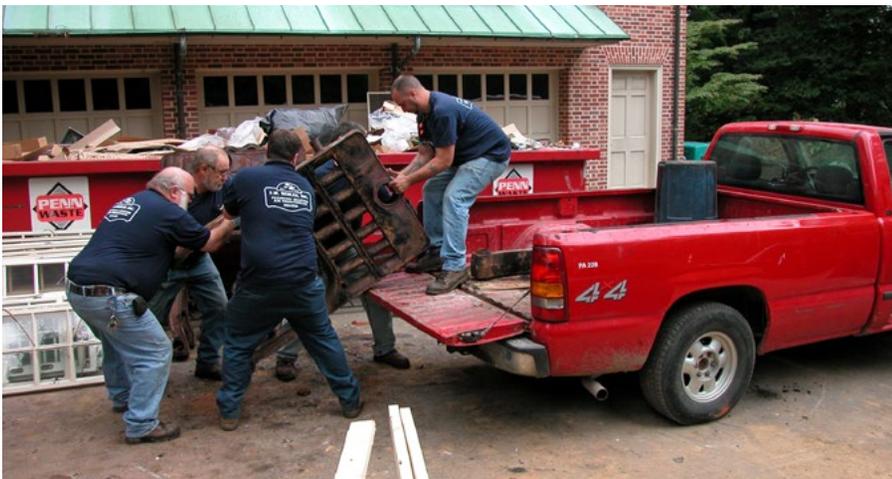
The F.W. Behler crew load a cast iron section to be recycled.

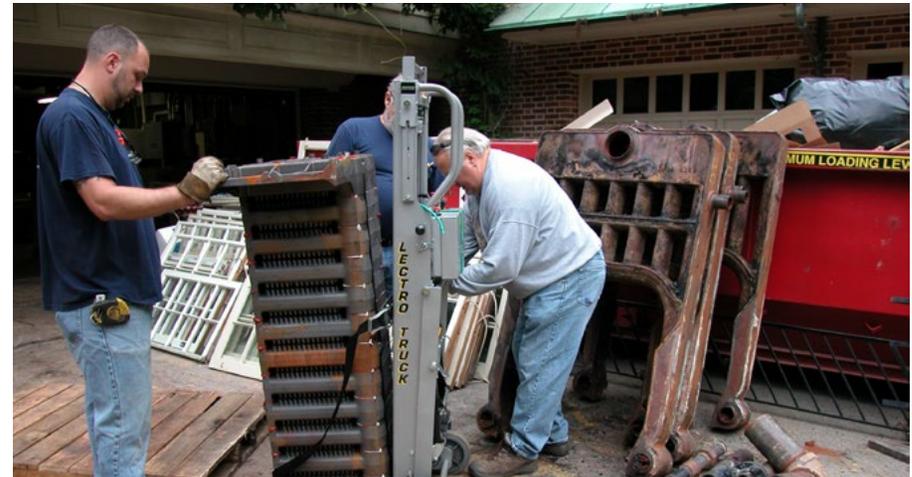
The F.W. Behler crew load a cast iron section to be recycled.

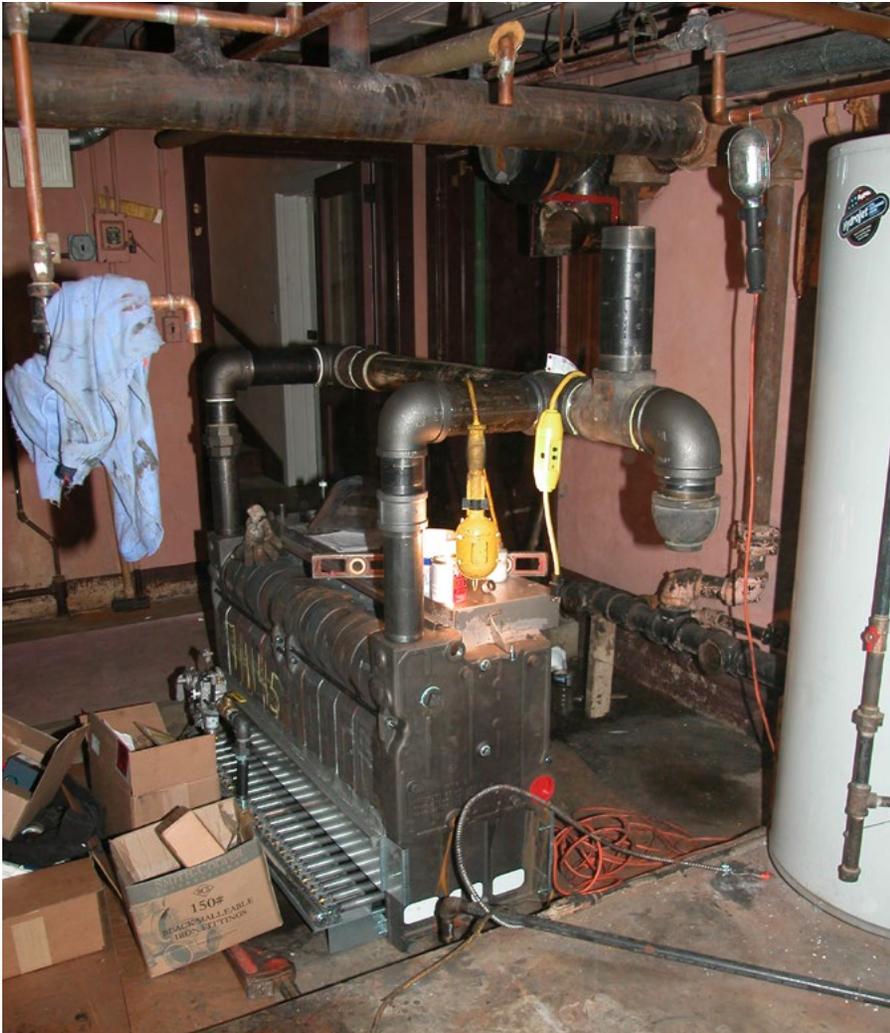
The new steam header and piping joins to the old system piping.

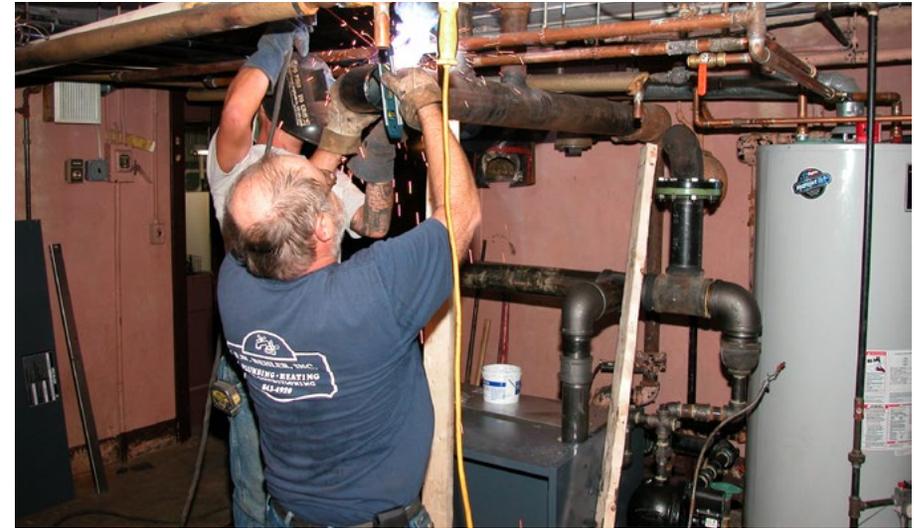
Scott Barnett with F. W. Behler works with the welder building the new steam piping on-site.

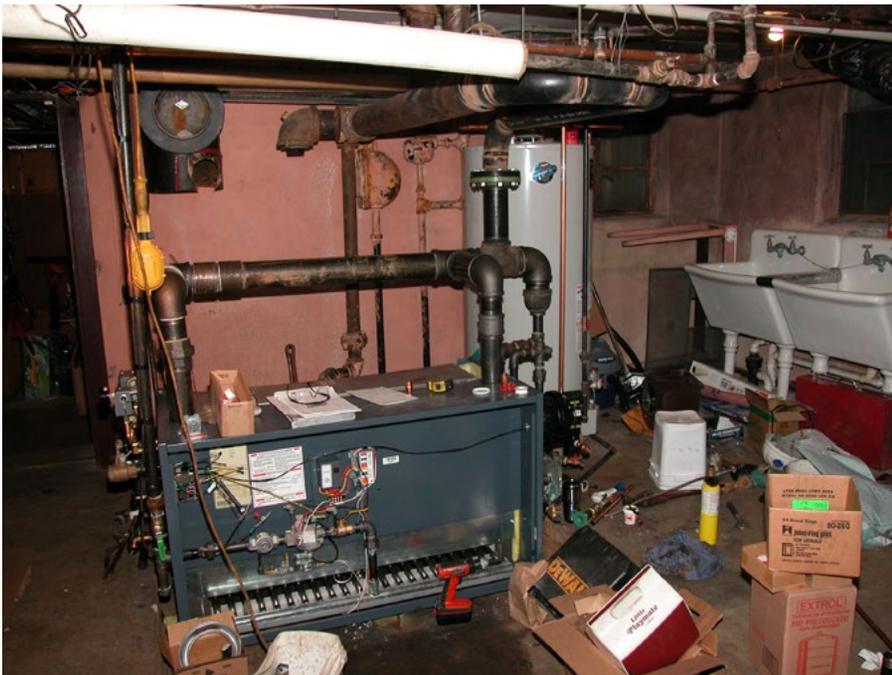
The new steam header and piping joins to the old system piping.

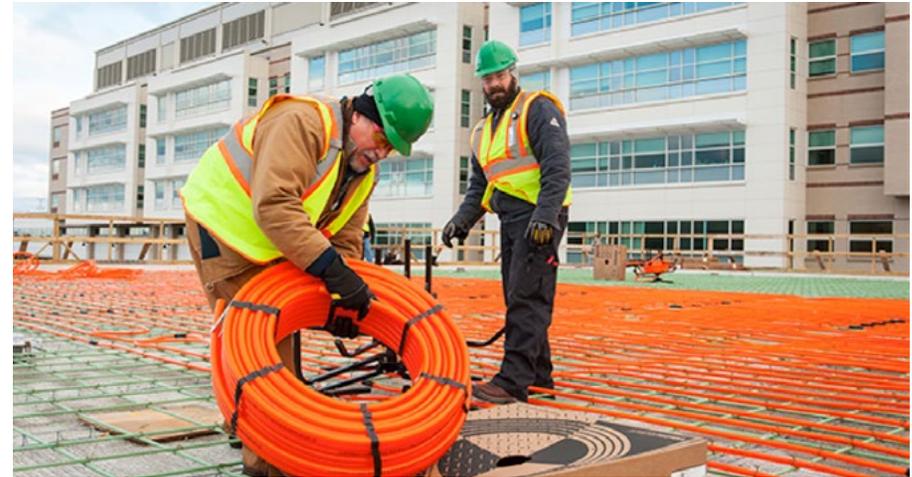
The hospital built a new, cutting-edge helipad as part of an ongoing \$50 million modernization of its emergency department.

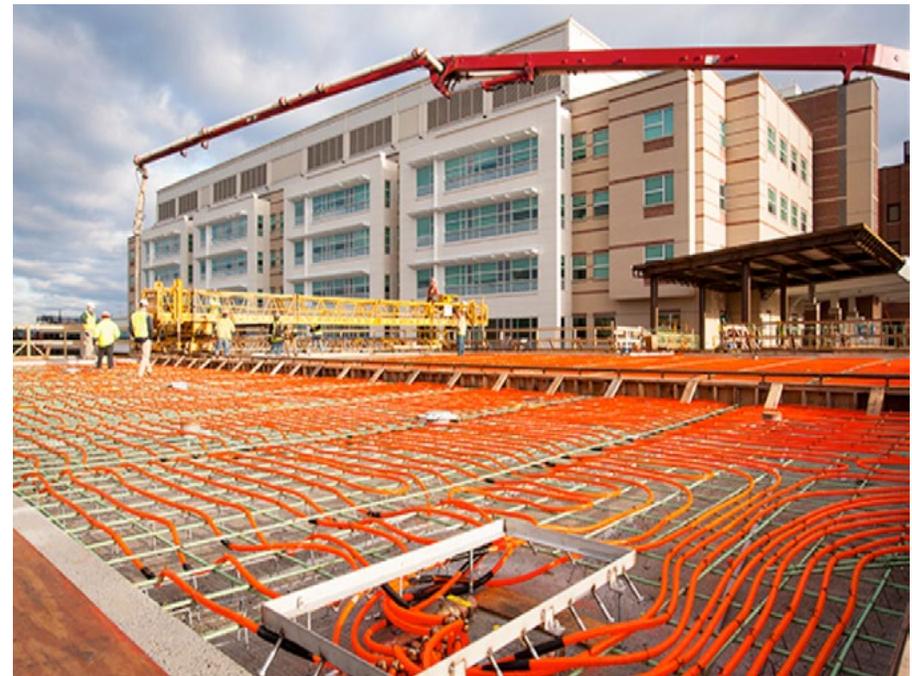
Fourteen miles of 3/4-inch Watts Radiant RadiantPEX+ with a 50% glycol mix were installed once the project was completed.

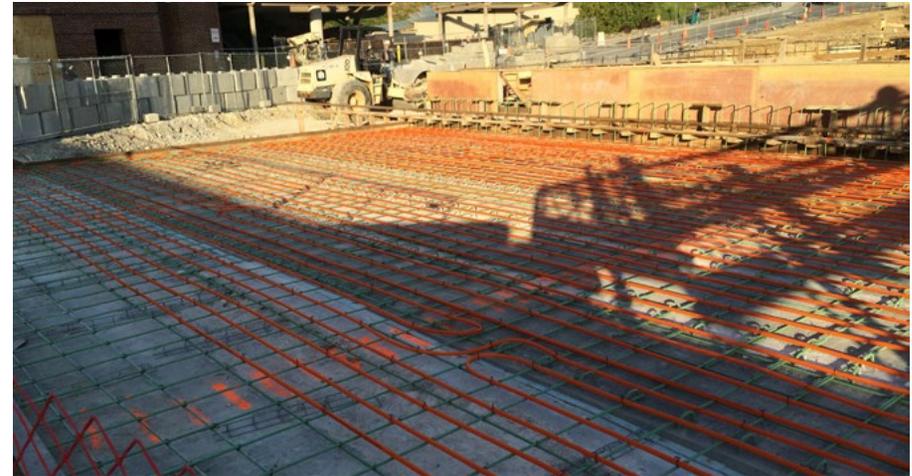
More than 16,000 lineal feet of 3/4-inch Watts Radiant RadiantPEX+ tubing was installed before the helipad's cement surface was poured.

More than 16,000 lineal feet of 3/4-inch Watts Radiant RadiantPEX+ tubing was installed before the helipad's cement surface was poured. A glycol mix solution runs through the radiant tubing to provide hydronic snow melting.

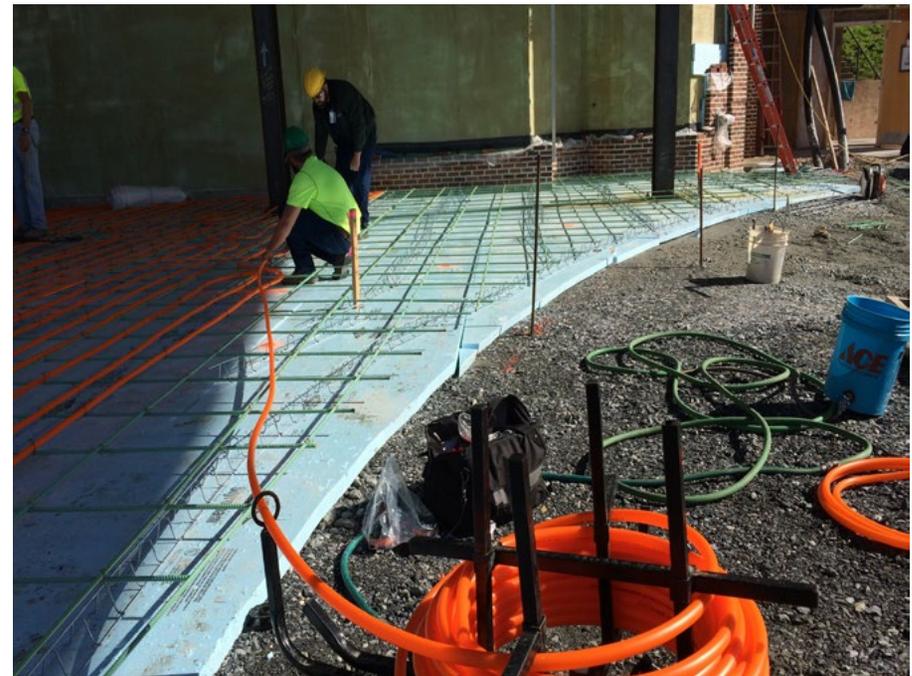
“Operation Helipad” required our crews to get the new launch pad up and running in the coldest of winter months.

The pad's design included several areas that would not have any tubing — as they were left open to the space below. This would ensure that in case of a crash landing or ruptured fuel tank, the fuel could drain away, avoiding an explosion and providing safe exit for personnel and the patient in the event fuel caught fire.

The biggest challenge was wrestling with 3/4-inch RadiantPEX+ in subzero weather. In addition, the helipad offered no shelter from weather and windy conditions.

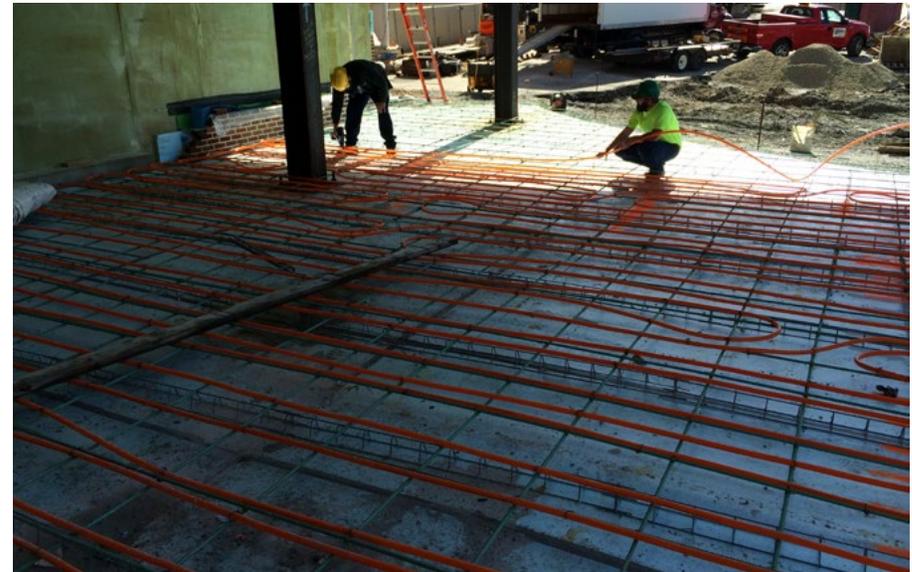
In all, 14 miles of 3/4-inch Watts Radiant RadiantPEX+ with a 50% glycol mix were installed once the project was completed.

In all, 14 miles of 3/4-inch Watts Radiant RadiantPEX+ with a 50% glycol mix were installed once the project was completed. That's

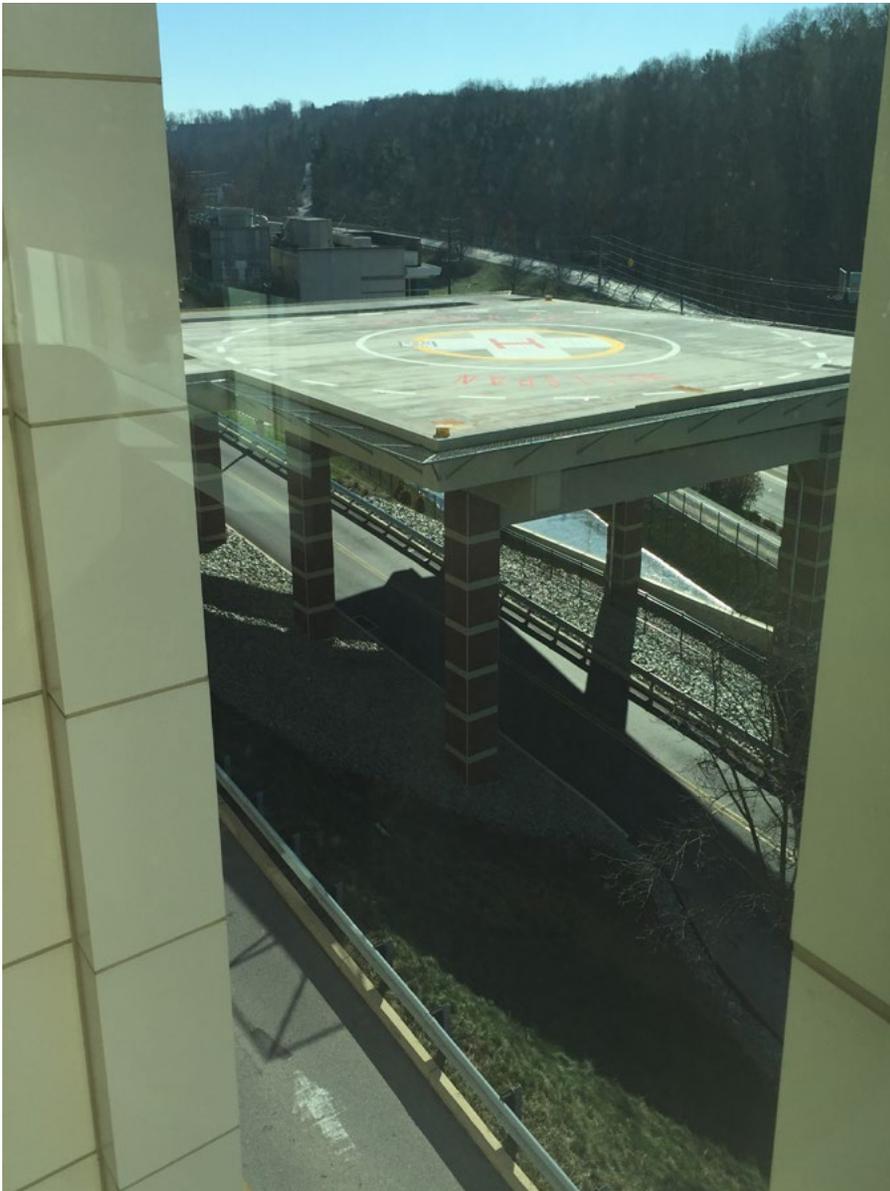
The hospital's new helipad, and other radiant snow melt areas, have been in operation for more than five years.

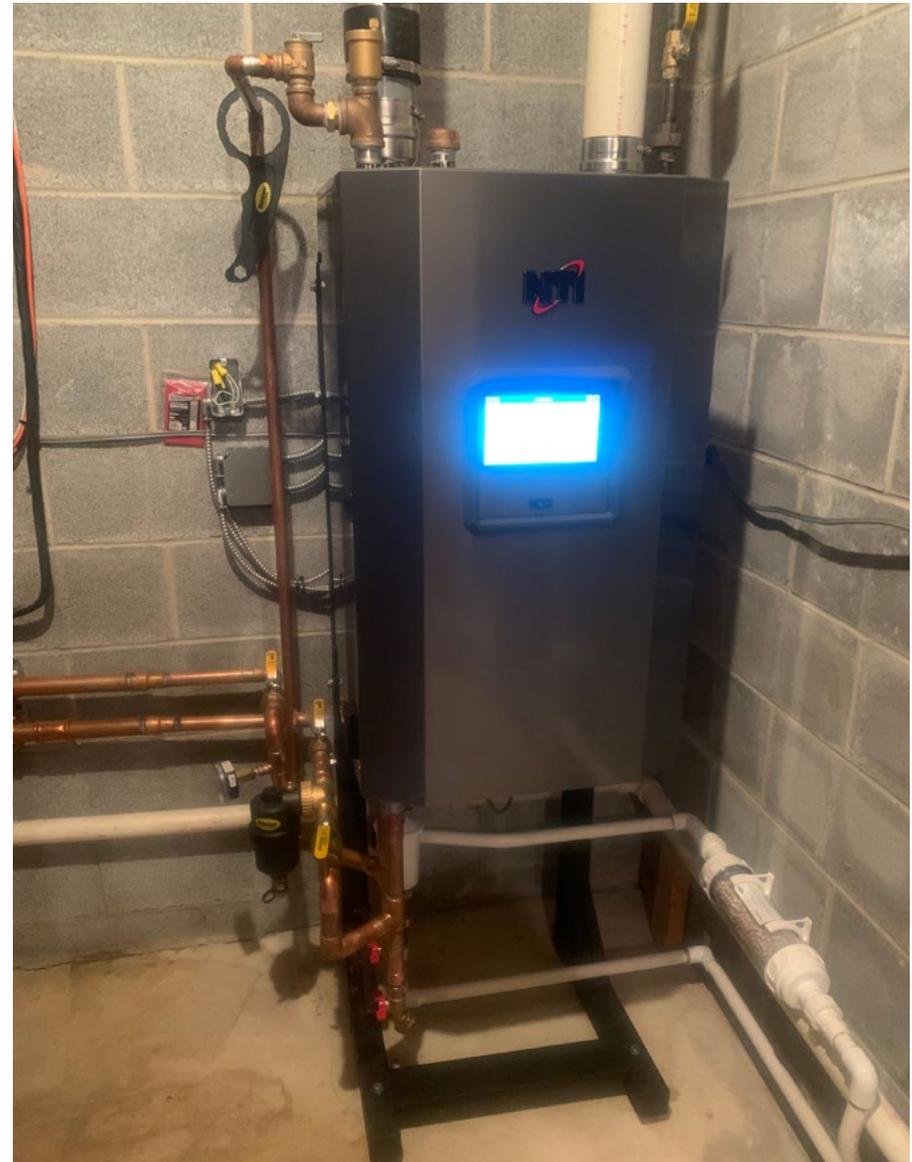
Acid condensate neutralizer is visible on the lower right. A black magnetic filter is on the lower left side of boiler.

Installing a magnetic filter to capture metals floating around in your hydronic water is rapidly becoming popular. It is amazing to see the crud these magnetic filters capture! Yet one more reason why you should be selling service agreements that include a water quality check and magnetic filter cleaning. Along with a combustion analysis and scheduled heat exchanger cleaning (per manufacturer’s guidelines) and, of course, testing safeties.
