ADVENTURES IN **HYDRONICS HEATING**

With Dave Yates ▶ **VOLUME 3**

2020 EXCLUSIVE QUARTERLY EBOOK SERIES

CONTENTS

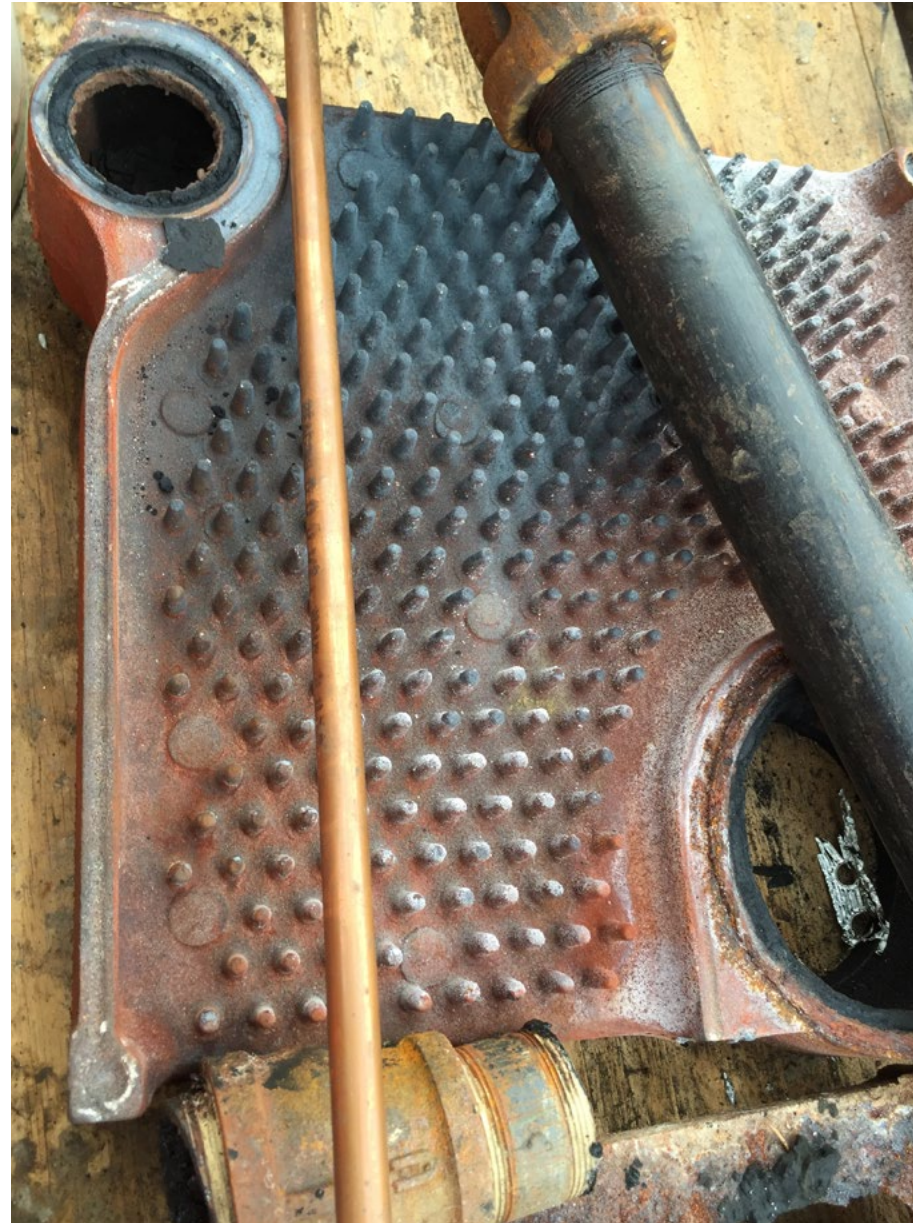
Cracked cast iron sections of a neglected steam boiler.

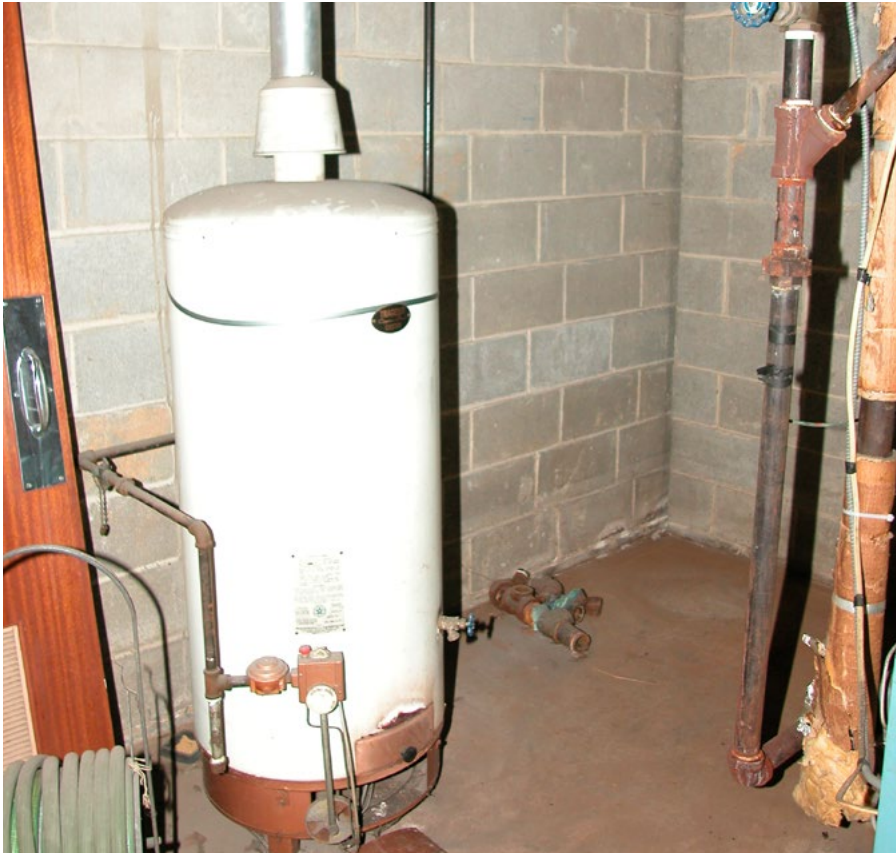
The old, tired water heater.

Continuing my visual tour, there was a vintage 1953 gas-fired water heater with its burner door lying on the floor and chrome skirt-ring tilted as if sadly hanging on by its fingernails.

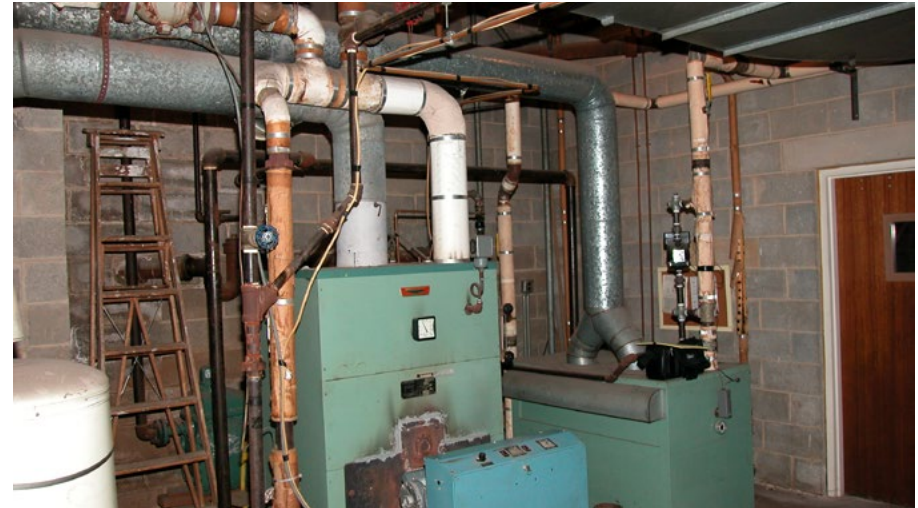
Pictured is the steam boiler on left with the hot water boiler on right.

The steam boiler was last, and from the numerous soot streaks at every opening in its jacket, this no doubt was the source of the CO leak. The technician who responded to the distress call had slathered refractory cement around the burner and chamber doors in an attempt to halt any CO from escaping. A gas boiler plus soot streaks equals bad combustion, and there was no evidence of anyone having utilized a combustion analyzer on this unit. A Burnham dual-fuel commercial burner was attached to the Peerless steam boiler!

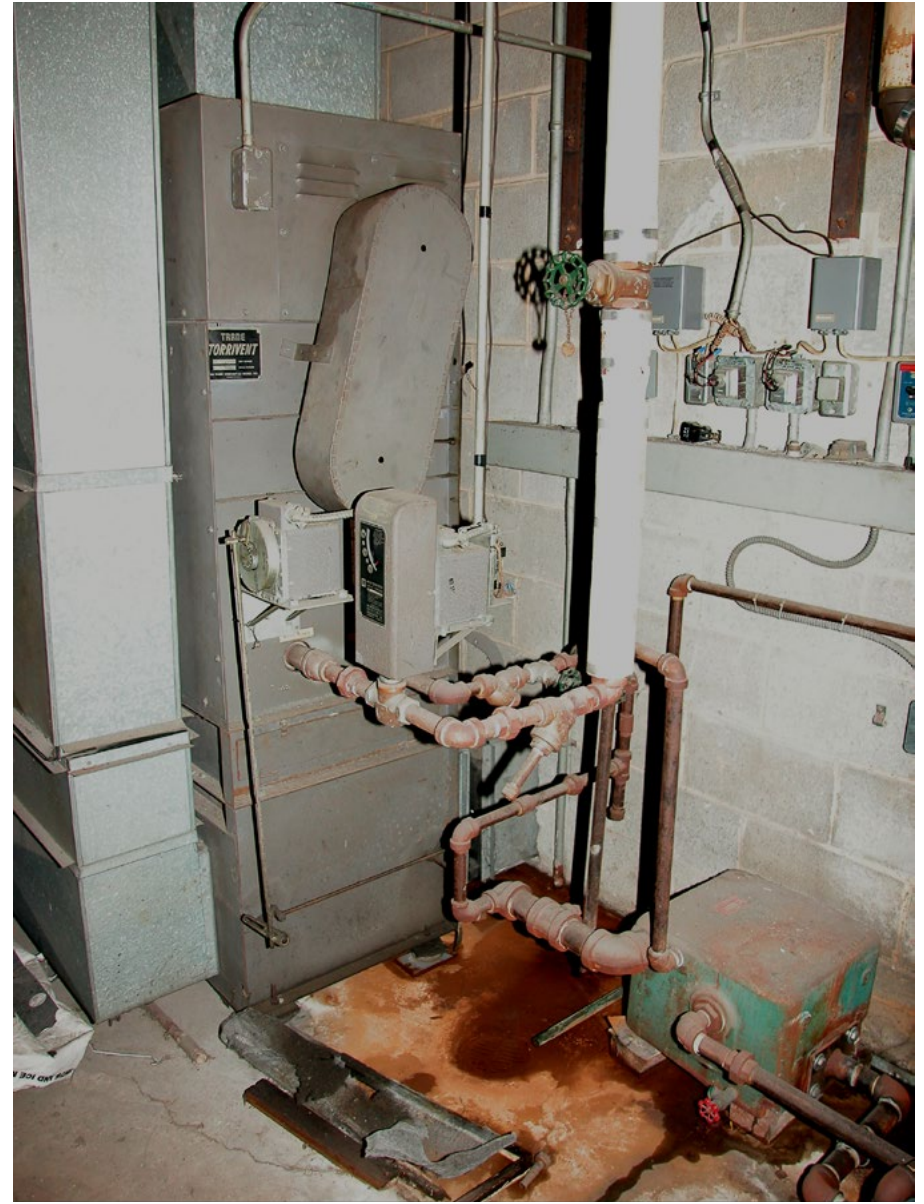
The old steam hydro-air unit.

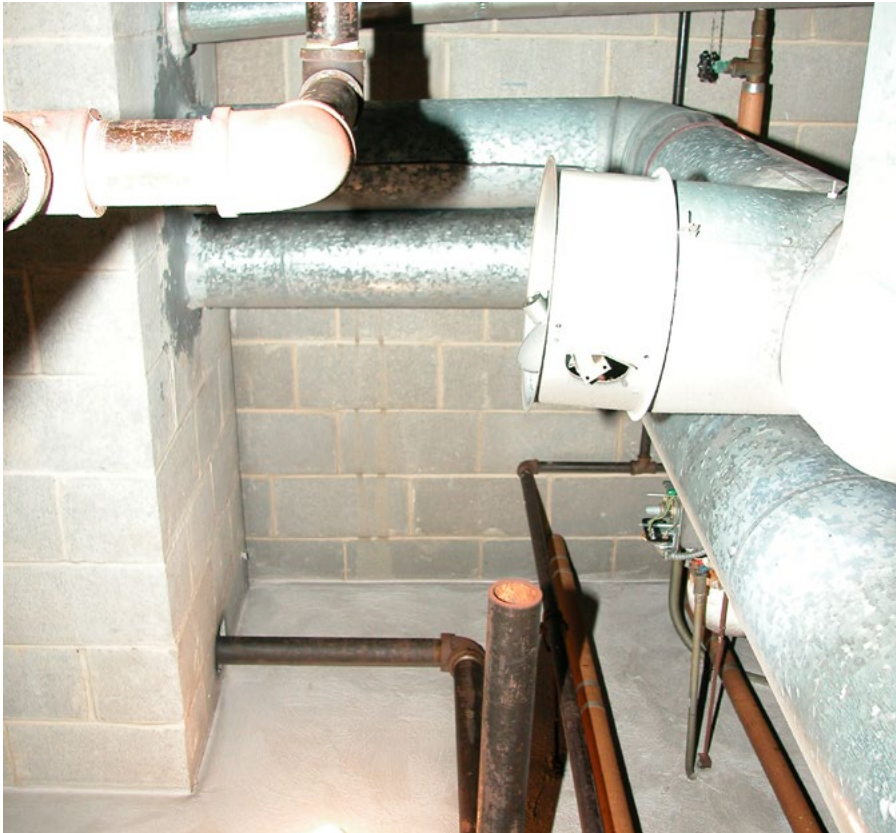
Pipe corrosion from acidic condensate dripping down from open pipe connected to chimney base.

- To the rear of the boiler and at the floor level, I noticed a return pipe that was severely corroded on its exterior. Looking directly above this spot, there was an open pipe connected into the chimney. Very old steam systems often saw their relief valves connected into the base of the chimney. It was not uncommon for those old system relief valves (not nearly as reliable as today's relief valves) to leak steam and letting them off-gas to the chimney was an accepted practice.

Evidently, the hot flue gases (remember — the boiler was being overstuffed with raw natural gas) are, to a limited degree, escaping from the chimney through this steel pipe. For every 100,000 Btu of energy burned in combustion, one gallon of moisture is generated if the temperature falls below 350° F. No doubt condensate from flue gases, which is corrosive, had been dripping onto this return line.

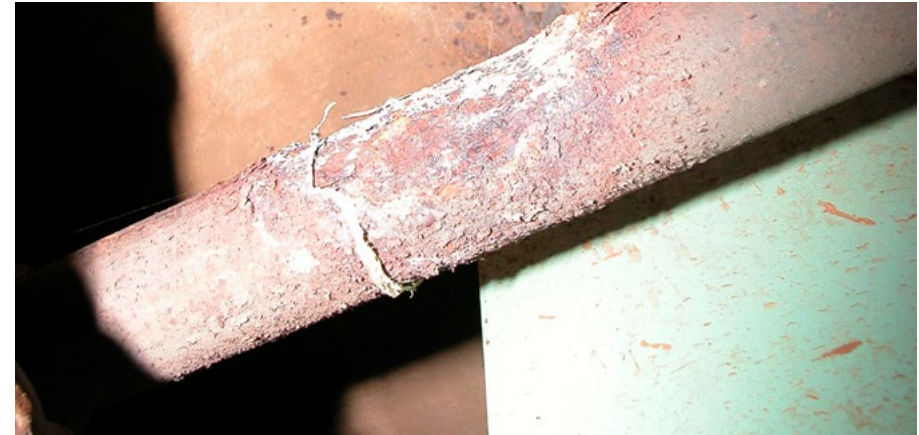
A close up view of acidic condensate damage on a pipe exterior.

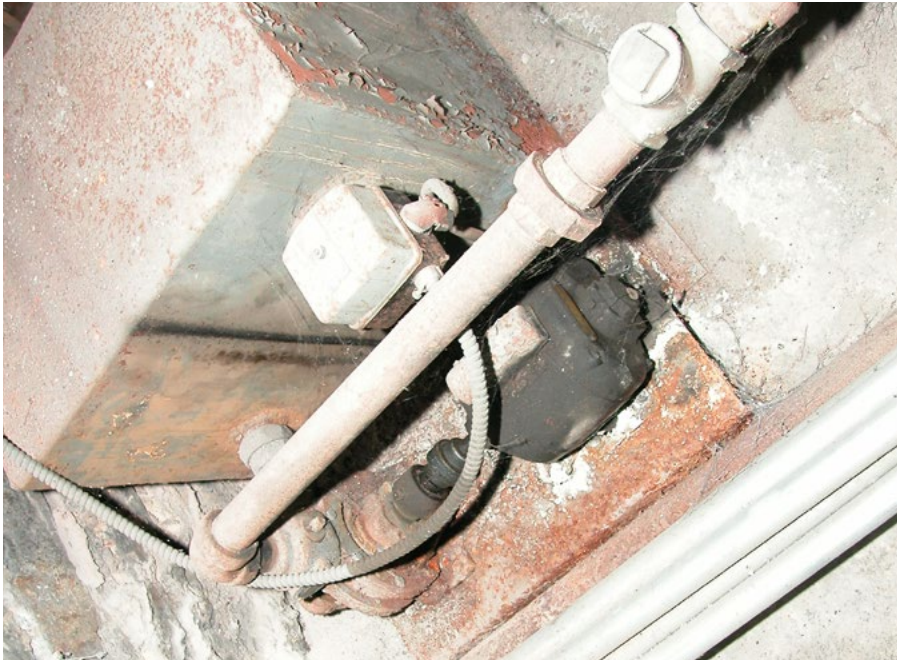
Pipe corrosion from acidic condensate dripping down from open pipe connected to chimney base.

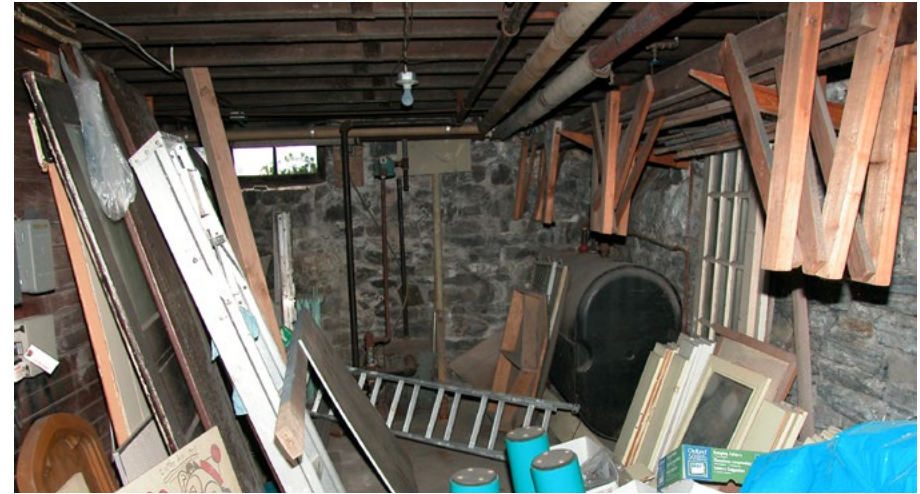
Where's Waldo? A remote antique condensate pump at the far end of the storage room, adjacent to an abandoned oil tank.

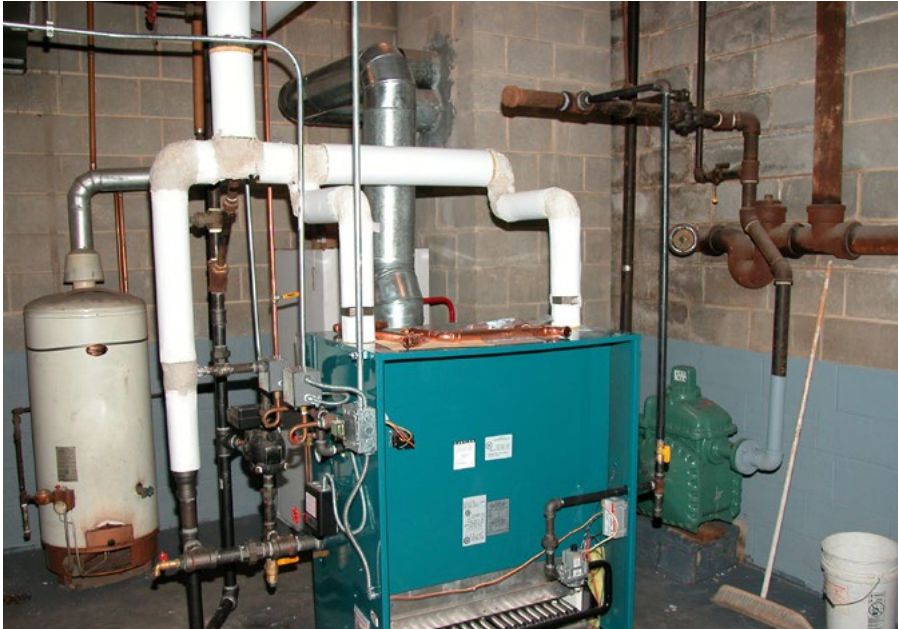
The new steam boiler in place.

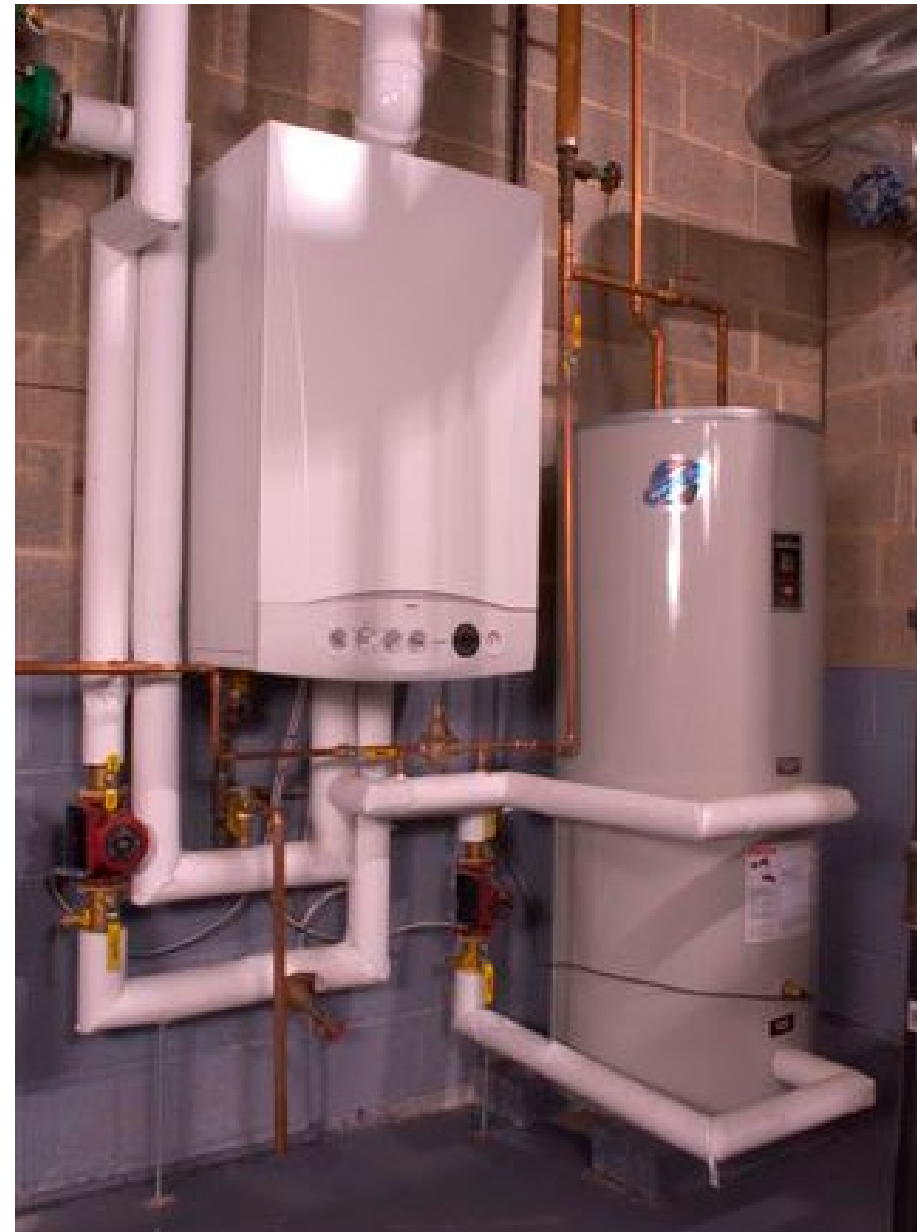
The Laars modcon boiler and Bradford White indirect water heater.

The boiler the Hammers chose (we always provide options) was a fully-modulating, sealed combustion, 85% AFUE LP gas endurance boiler/water heater made by Laars. Its internal bypass, pump, heat

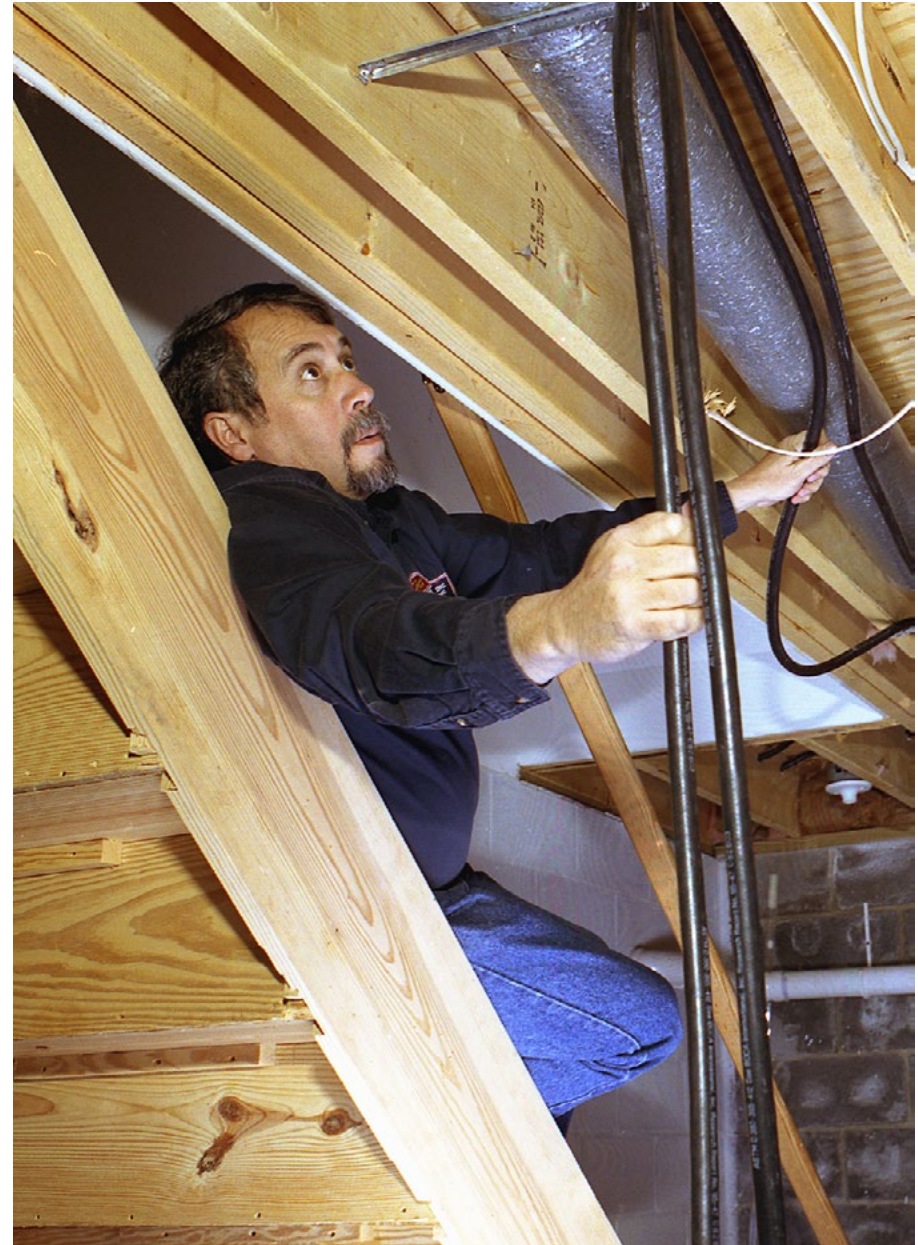
Dave Yates threads Onix tubing through the joist bay. Photo by John Herr.

About 1,200 linear feet of Watts Radiant EPDM “Onix” tubing was ordered for the home’s staple-up radiant system, chosen because of the several advantages it offered. We like the material because of its excellent heat transfer when stapled-up. The tubing, by design, is slightly flattened against the underfloor when stapled into position. This greatly increases the surface area for contact with subfloor, moving heat out of the tubing and into the floor — without metal plates. Its rope-like flexibility gives it two other key advantages for

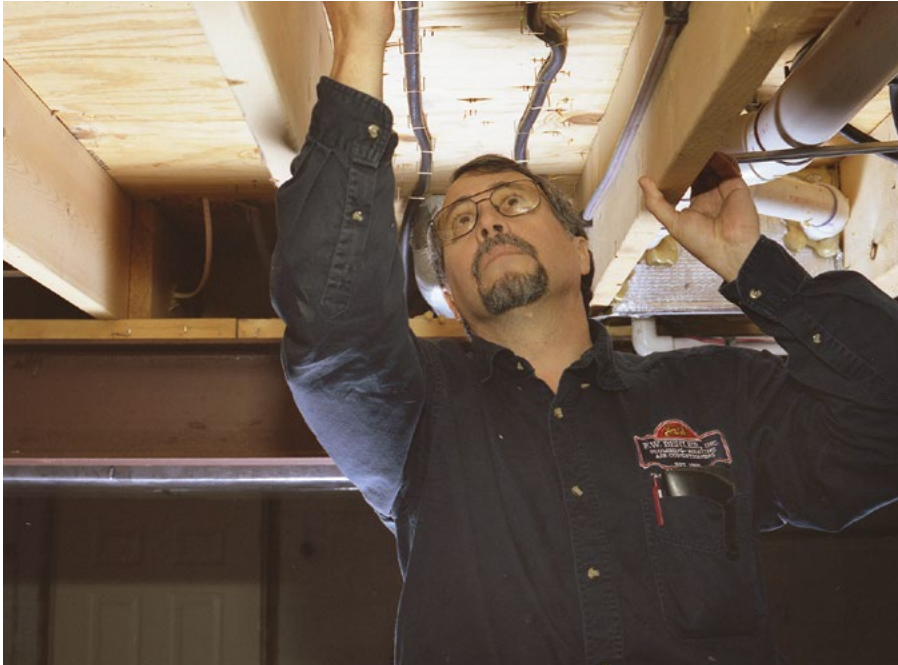
Dave Yates checks installed Onix tube staple-up. Photo by John Herr.

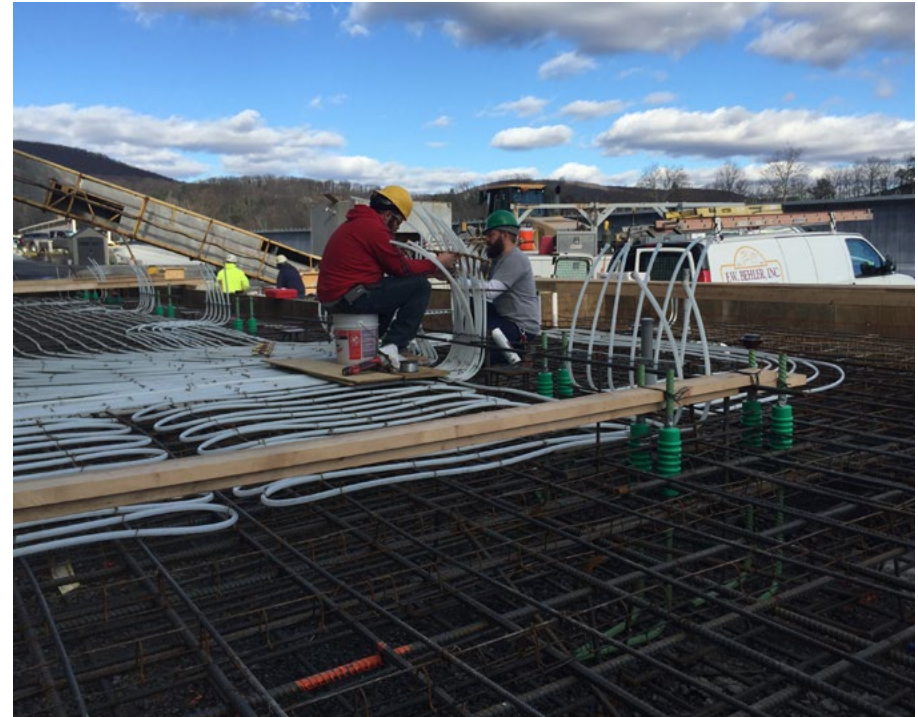
Installing a test manifold while working atop the three foot thick rebar assembly.

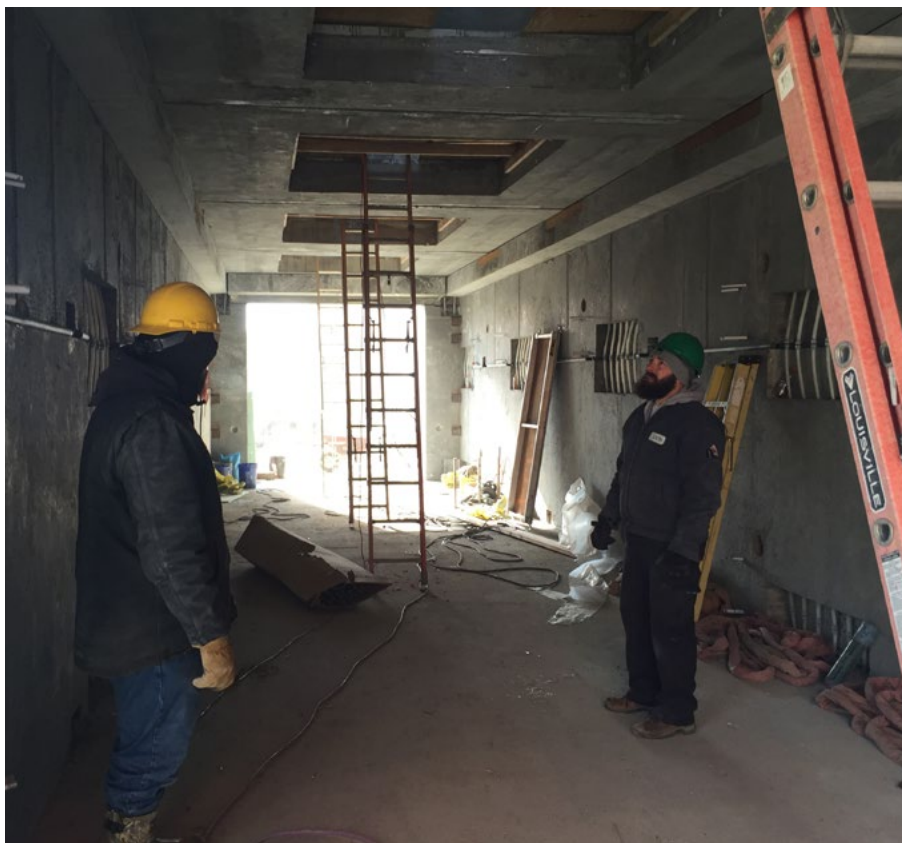
The lower floor of the radiant bunker.

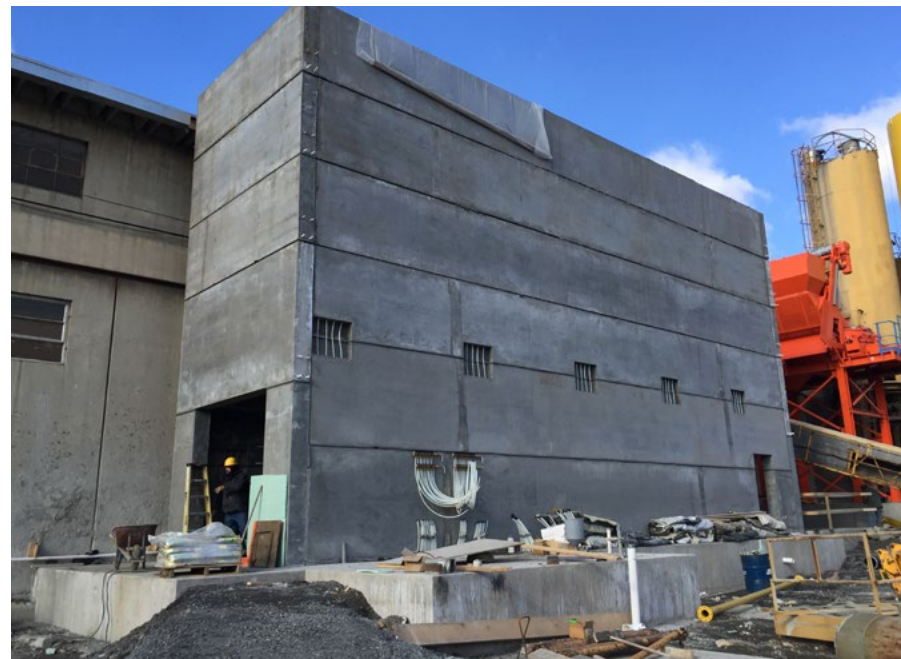
The radiant bunker completed.

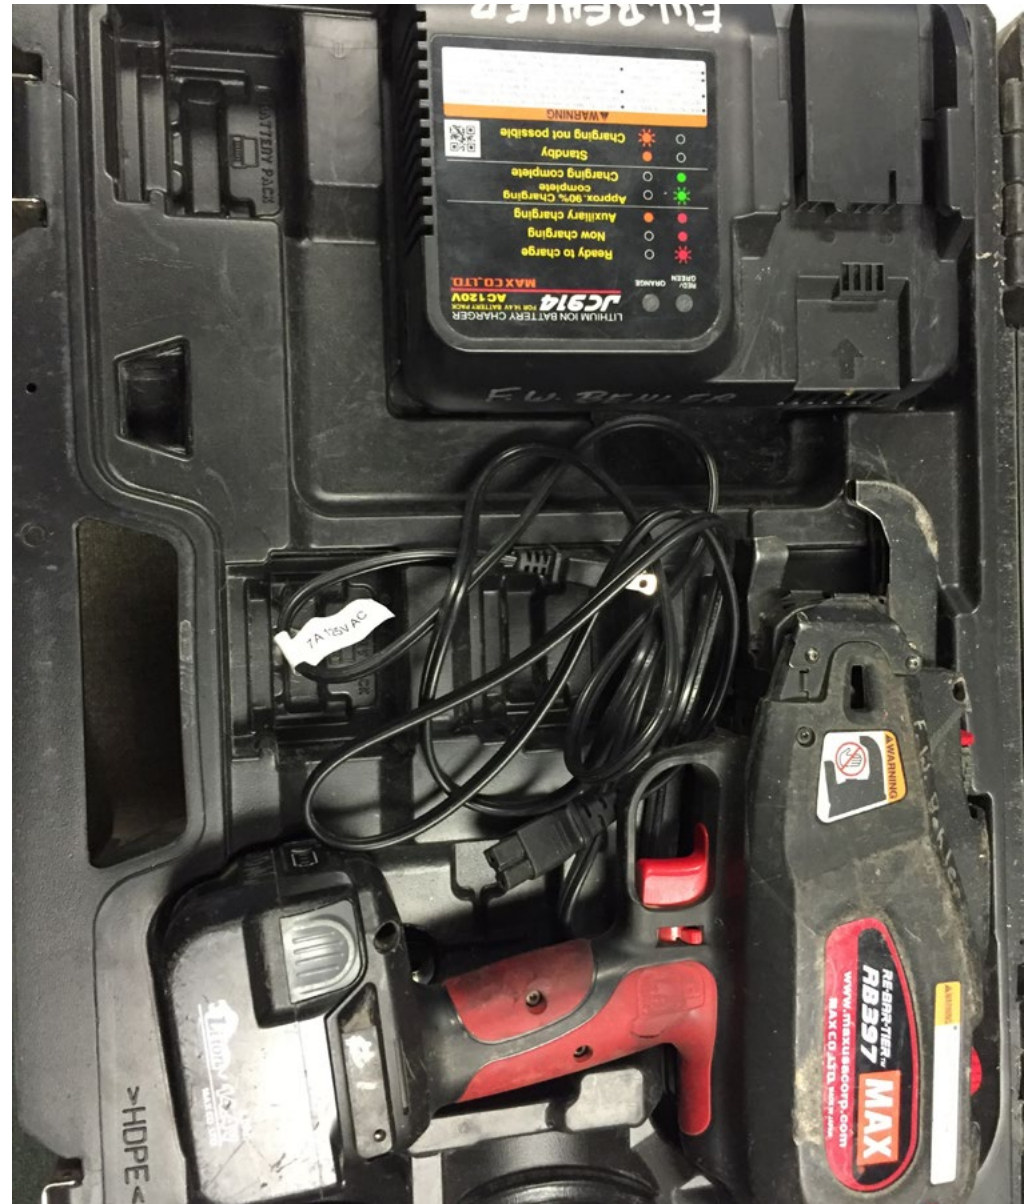
The lightning fast tie tool for fastening PEX to rebar.

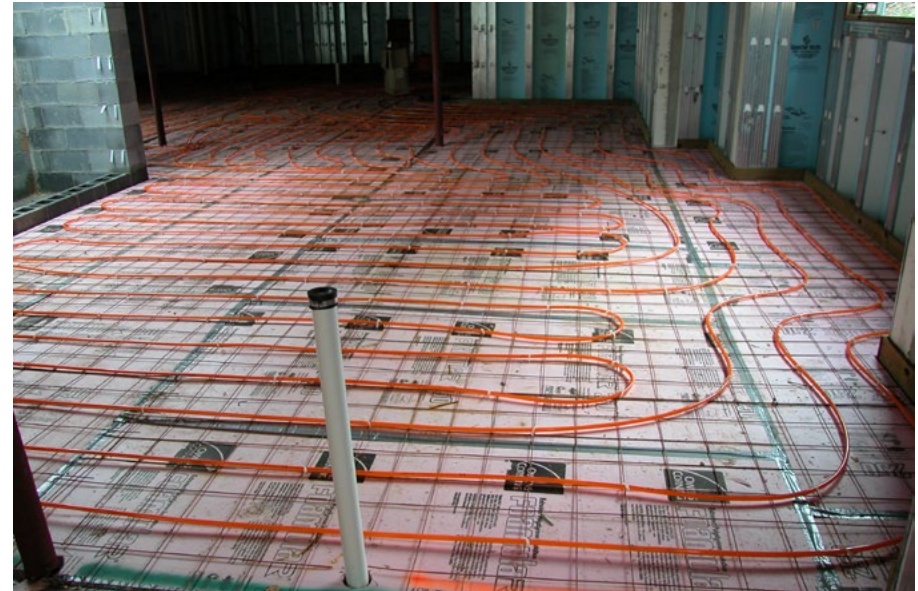
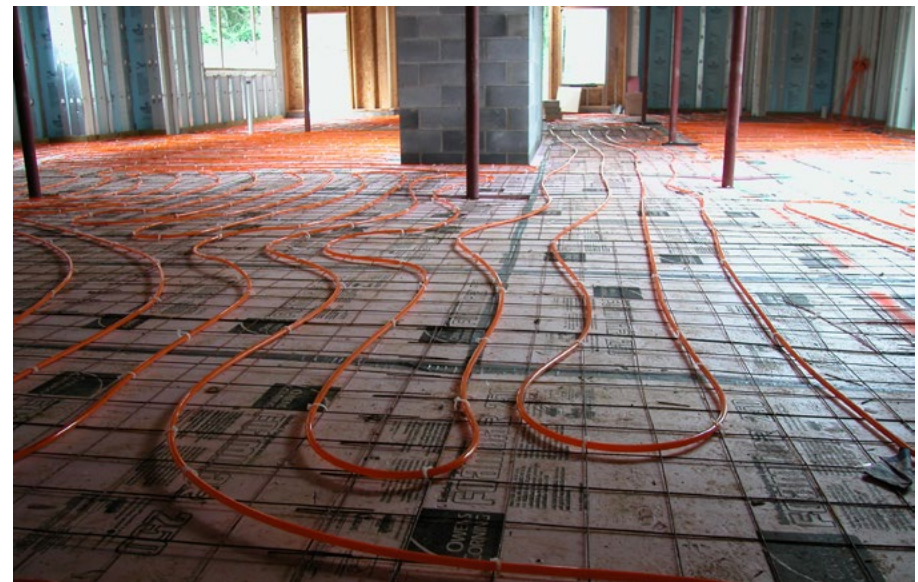
The basement level Watts HEPEX tubing ready to receive concrete overpour.

We installed more than 12,000 linear feet of Watts HEPEx oxygen-barrier tubing in the concrete slab at nine-inch and 12-inch centers.

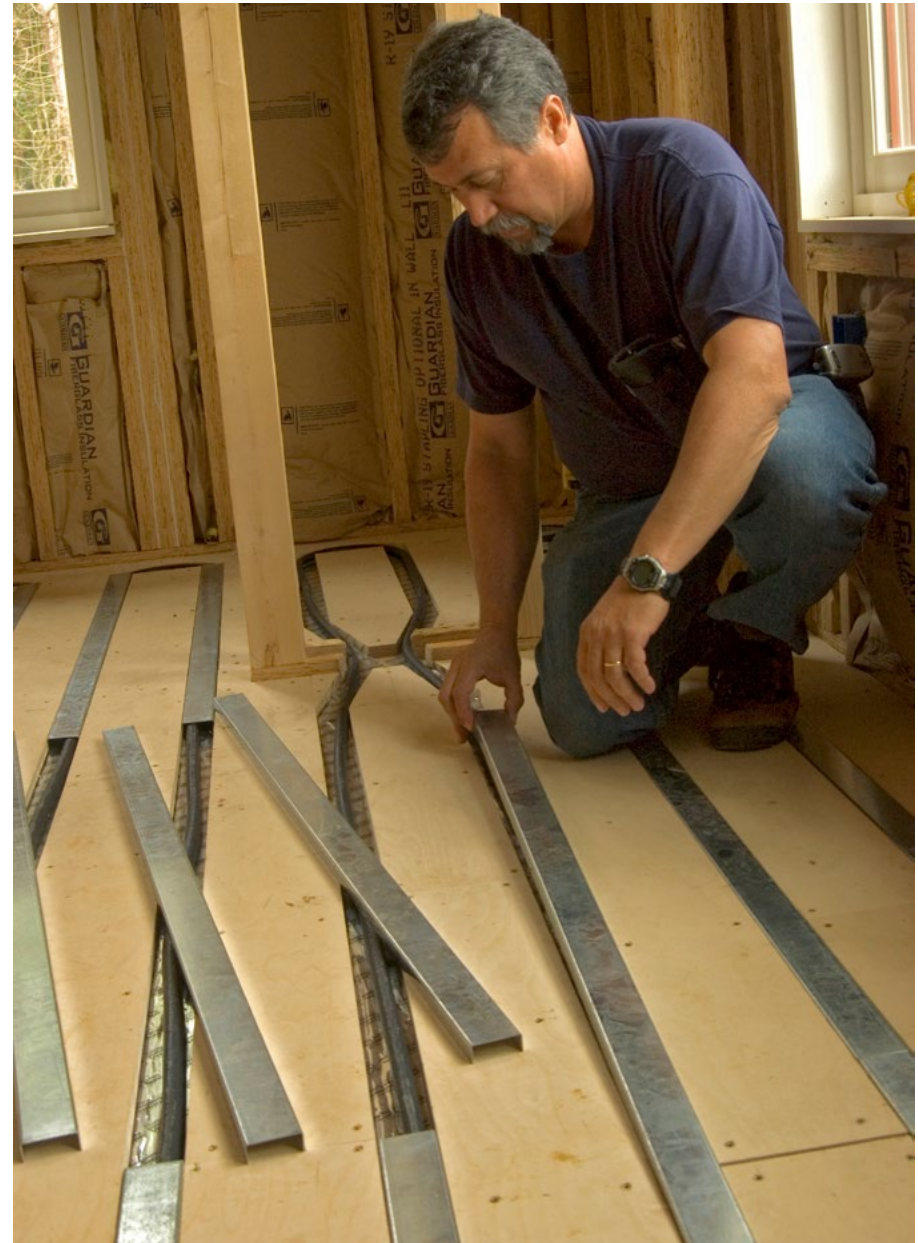
Dave Yates installs metal plates over Onix tubing in SubRay panels.

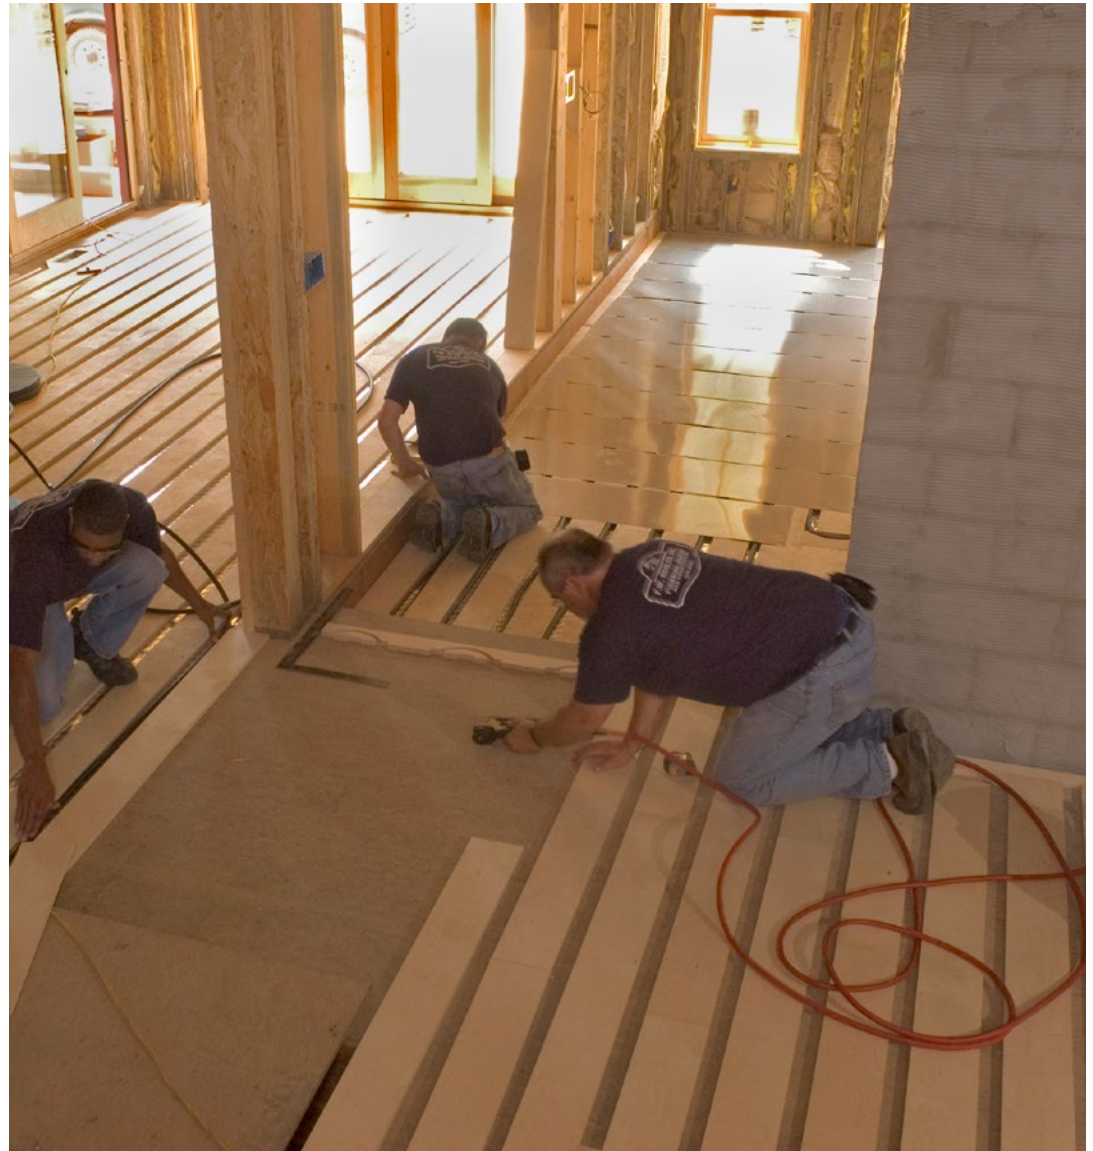
The Behler crew installs Watts SubRay panels, Onix tubing and heat transfer plates.

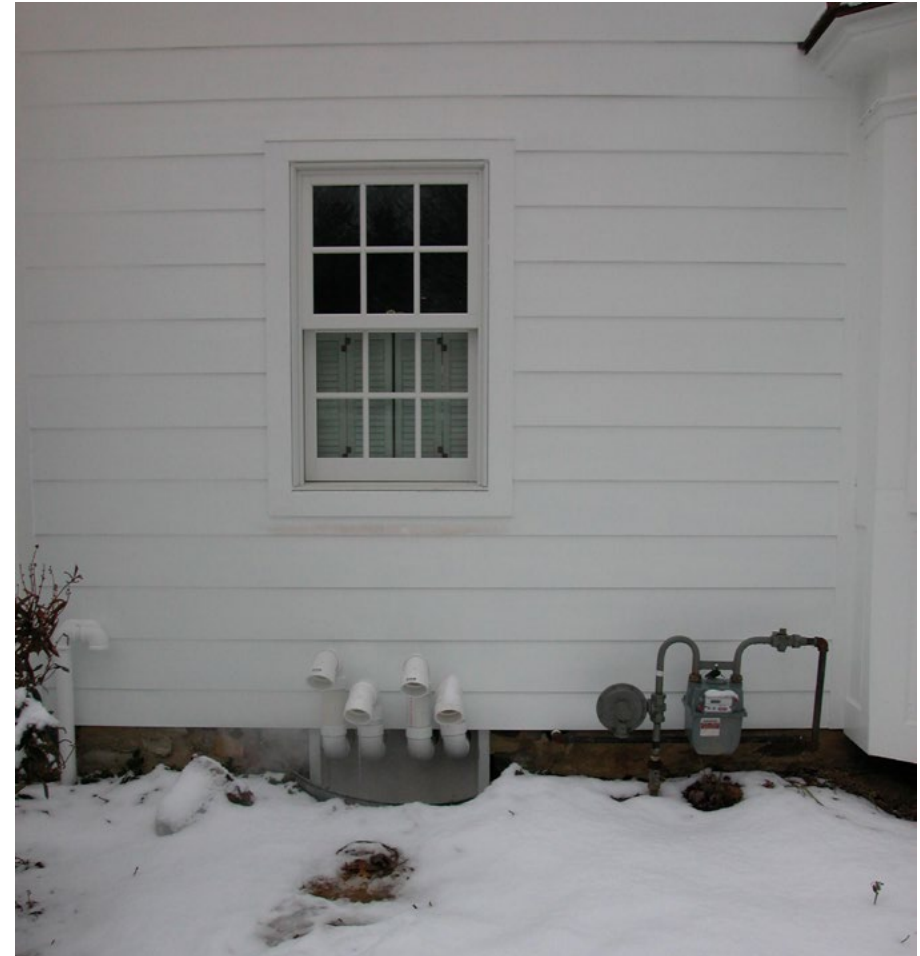
The original vent terminations.

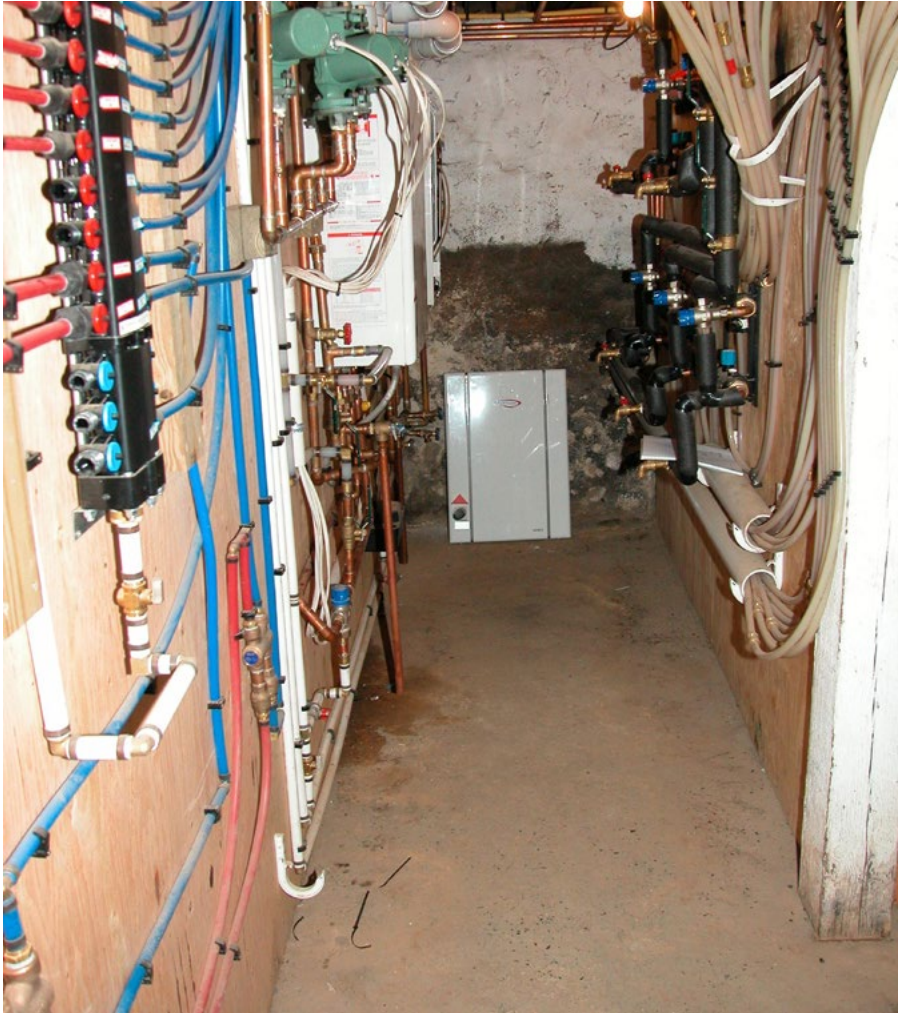
The mechanical nook created very tight quarters.

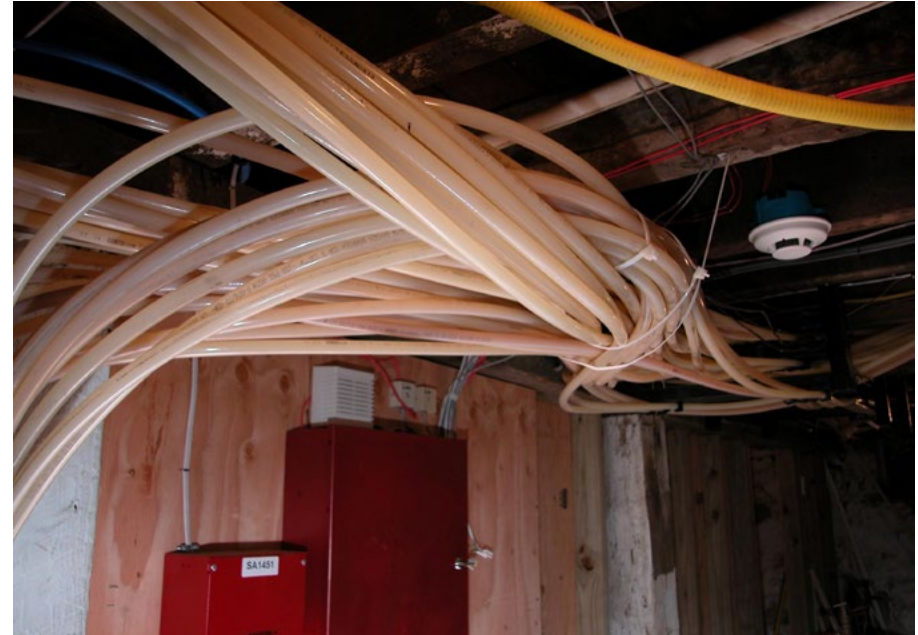
PEX spaghetti held up with plastic strapping that broke.

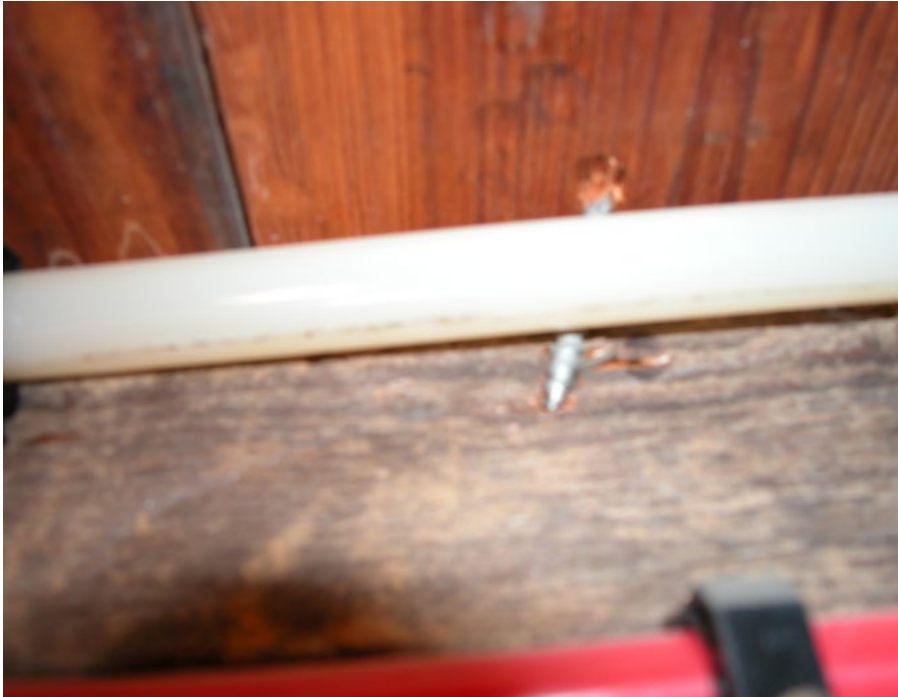
PEX installed in contact with sharp screw threads.

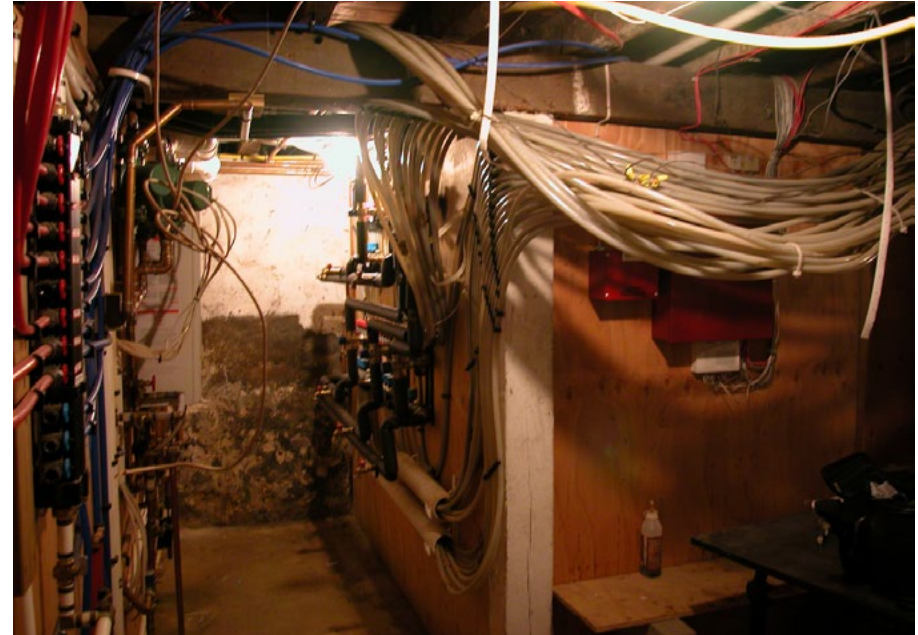
Nightmare on PEX Street!

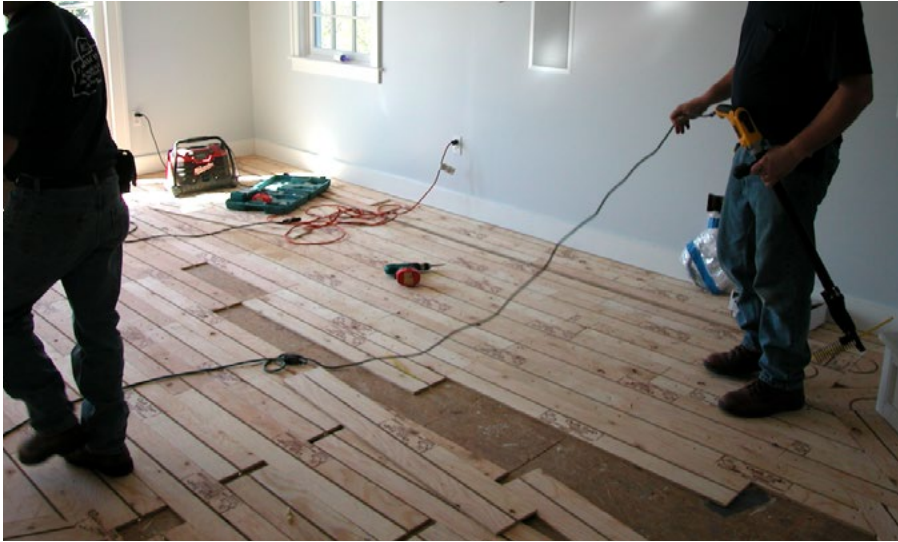
Installing QuikTrack in the master bedroom.

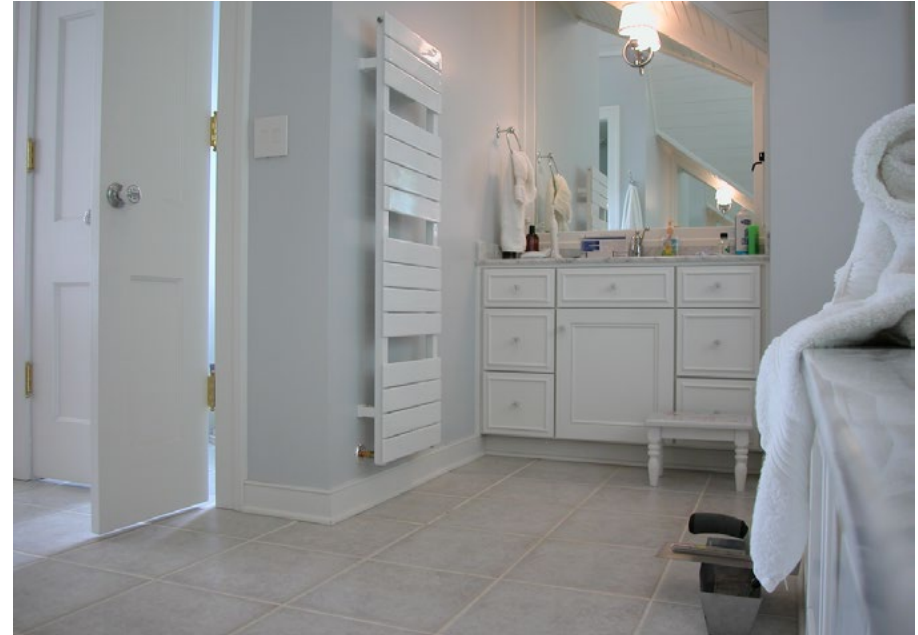
Master bathroom combi-towel warmer and radiant flat panel radiator to supplement heating.

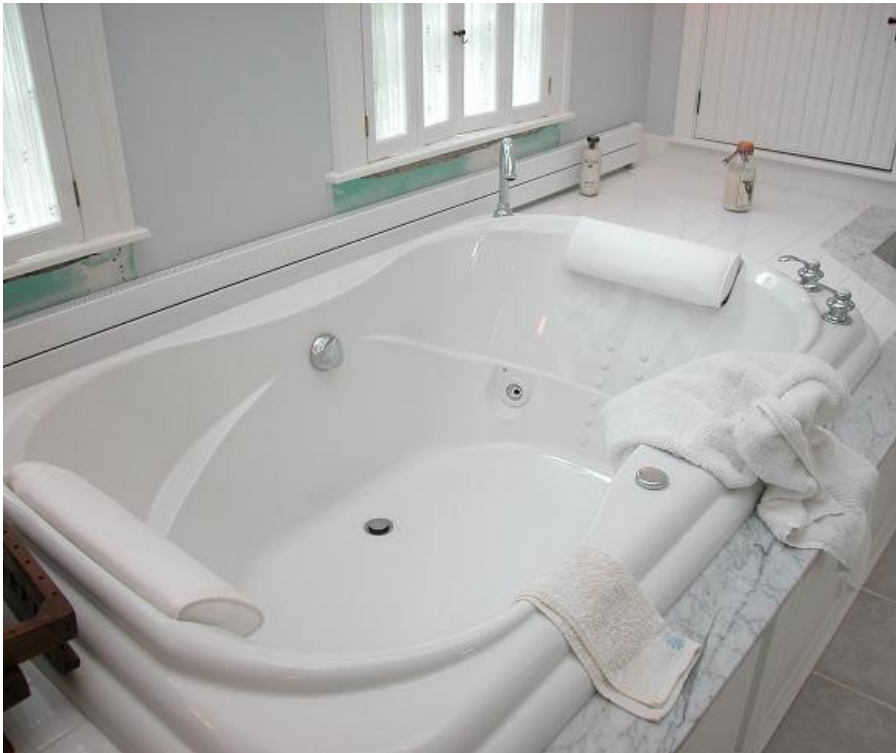
The flat panel radiator to offset chill from adjacent window and supplement heating.

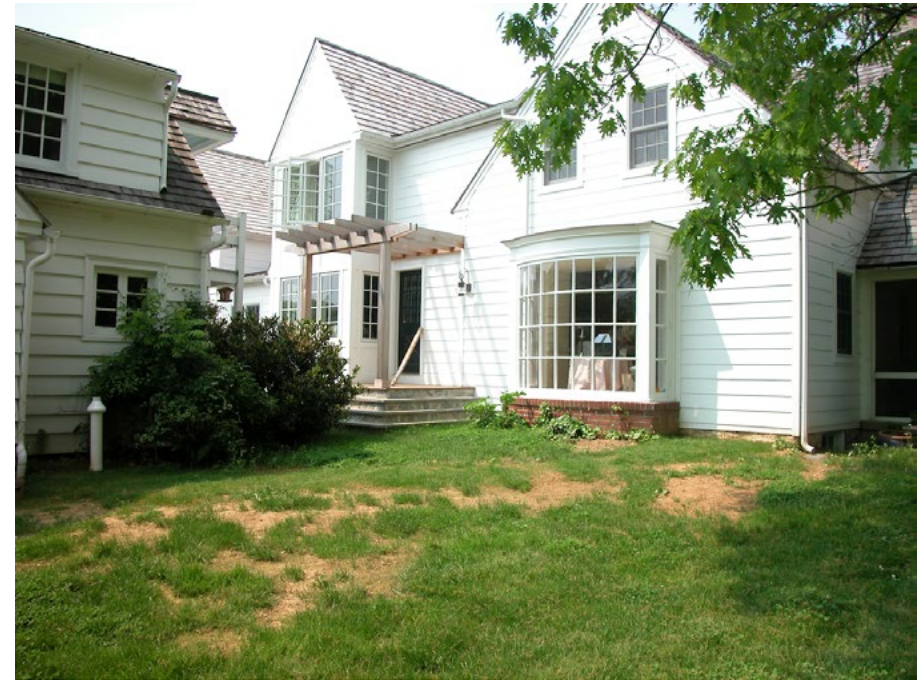
The final combined combustion exhaust/intake, located away from the home.
