ADVENTURES IN **HYDRONICS HEATING**

With Dave Yates ▶ **VOLUME 3**

2020 EXCLUSIVE QUARTERLY EBOOK SERIES

CONTENTS

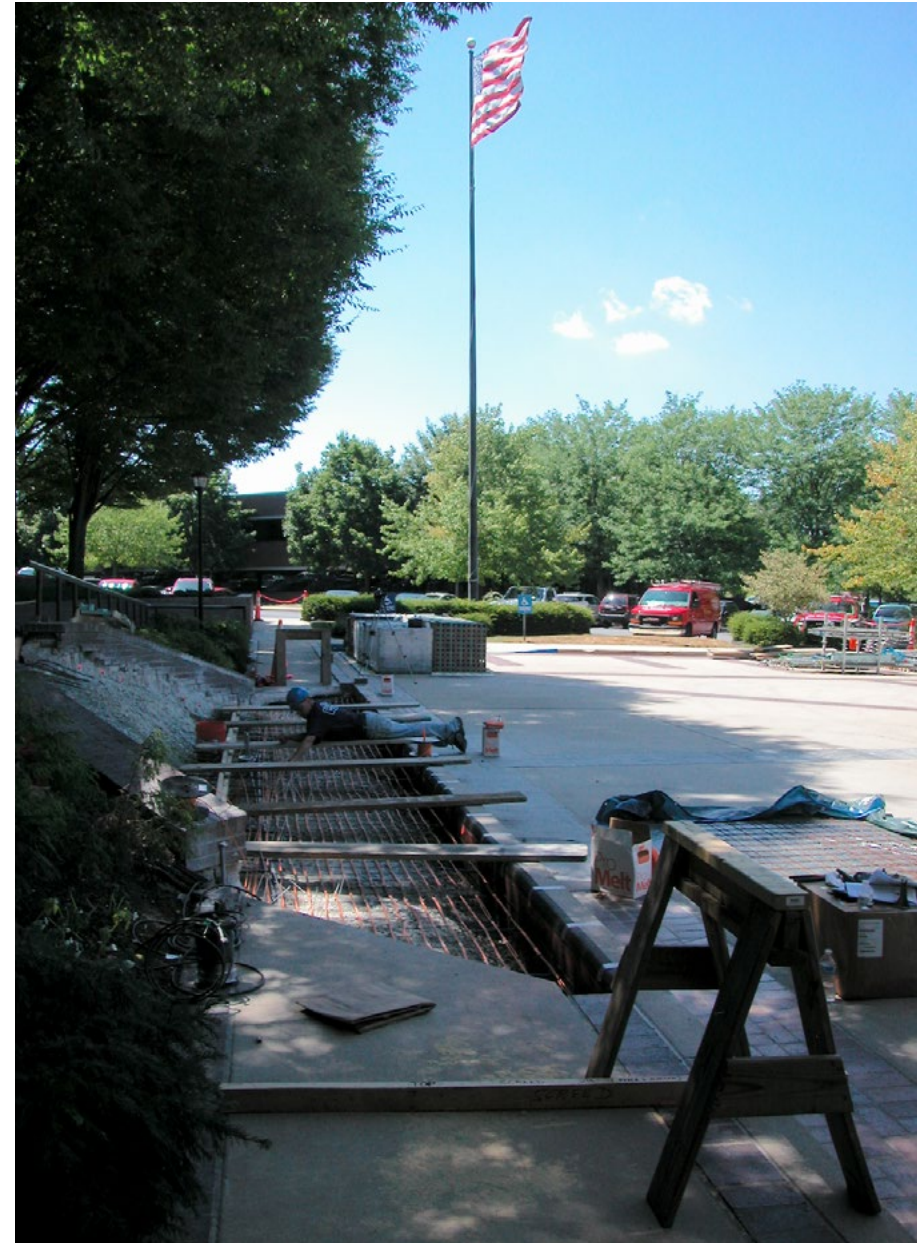
ProMelt cables are installed on the lower sidewalk.

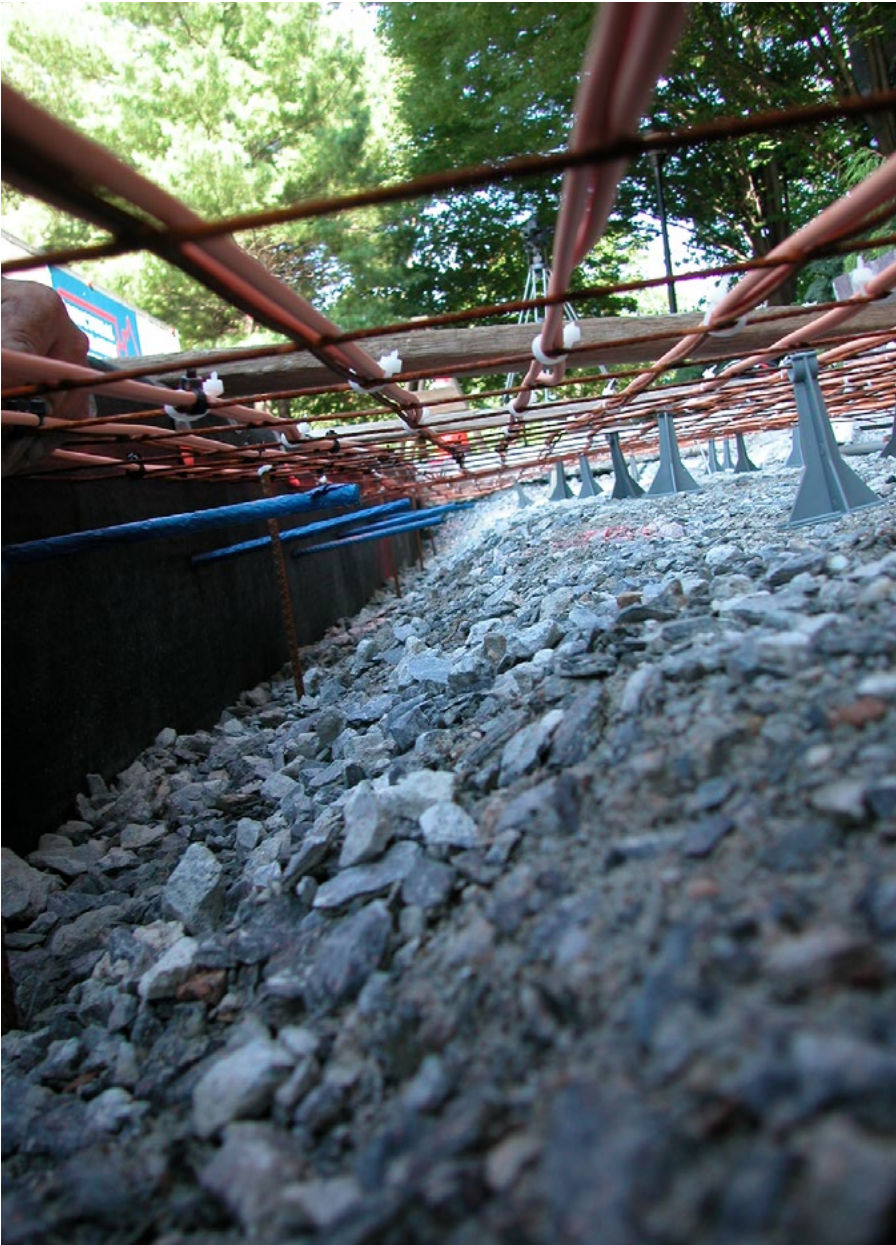
A view of the underside wire grid supported by chairs.

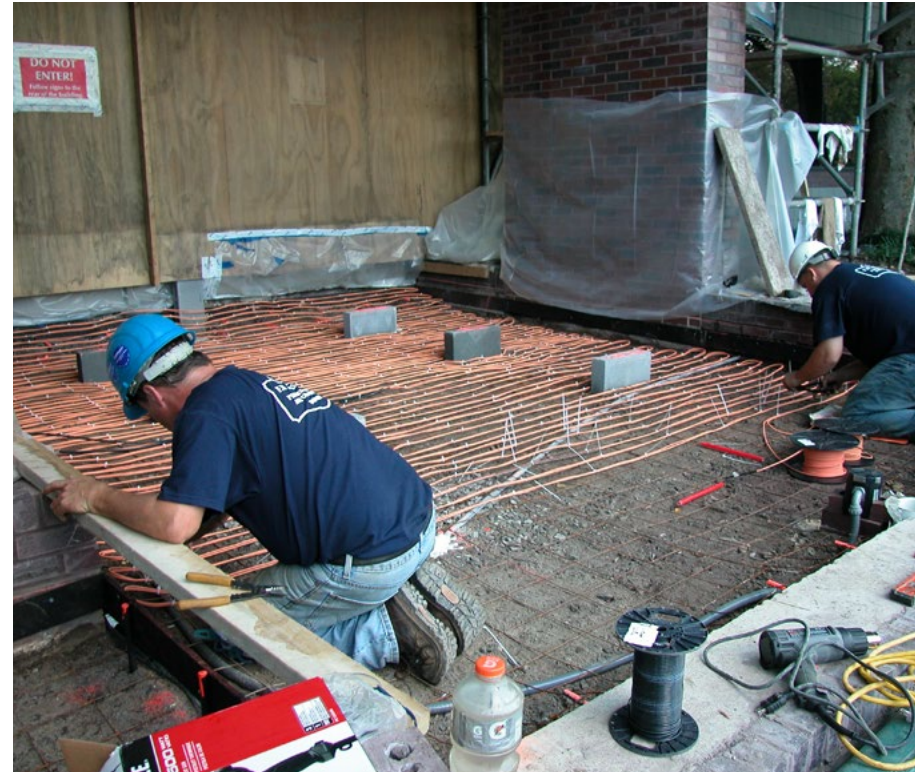
ProMelt cables are installed on the upper landing.

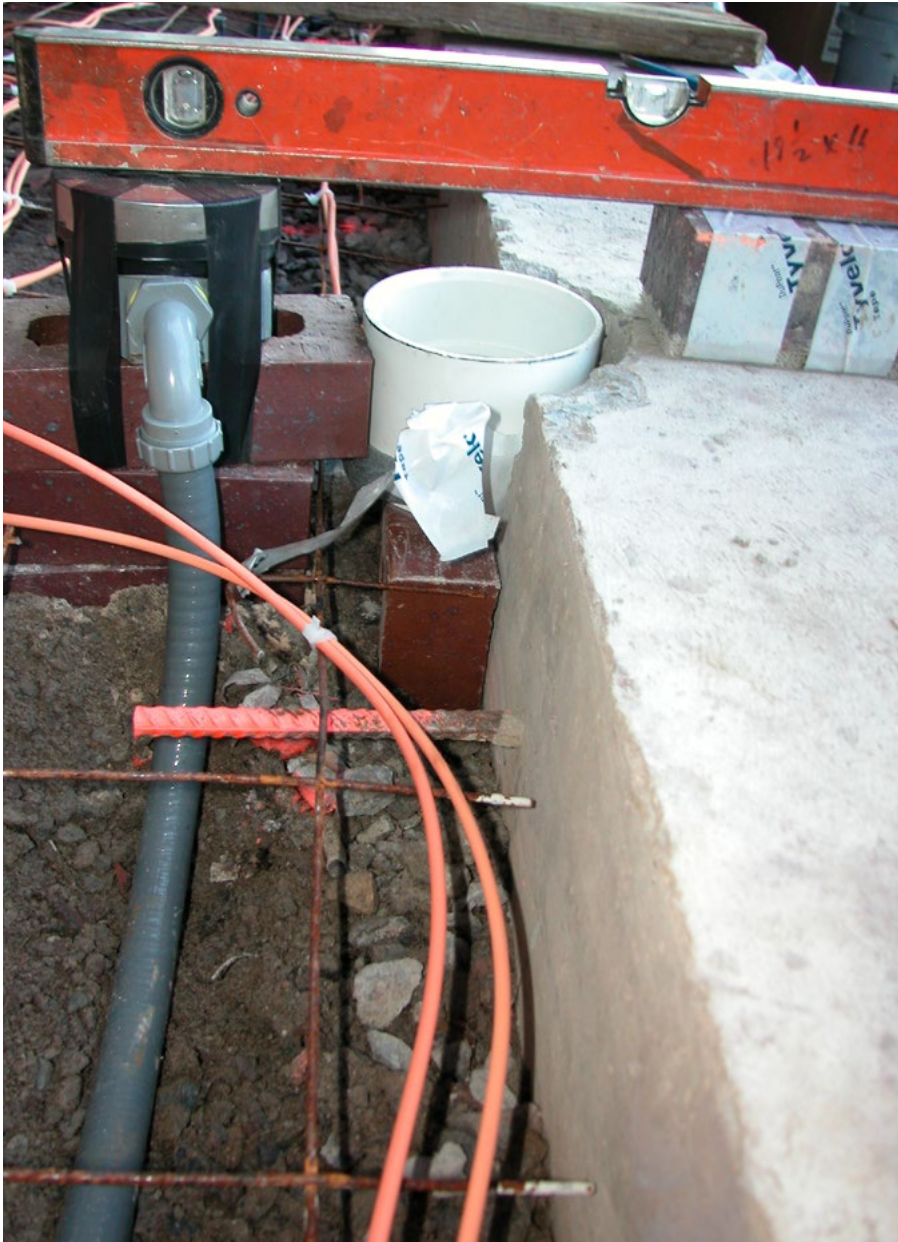
A Watts snow melt sensor body is installed.

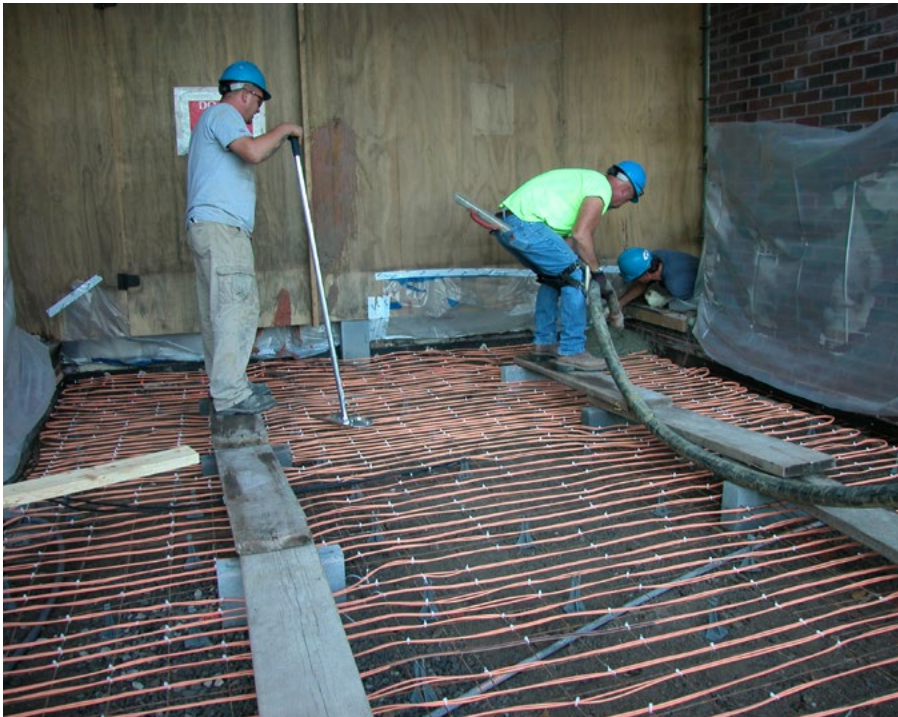
The concrete pour getting underway.

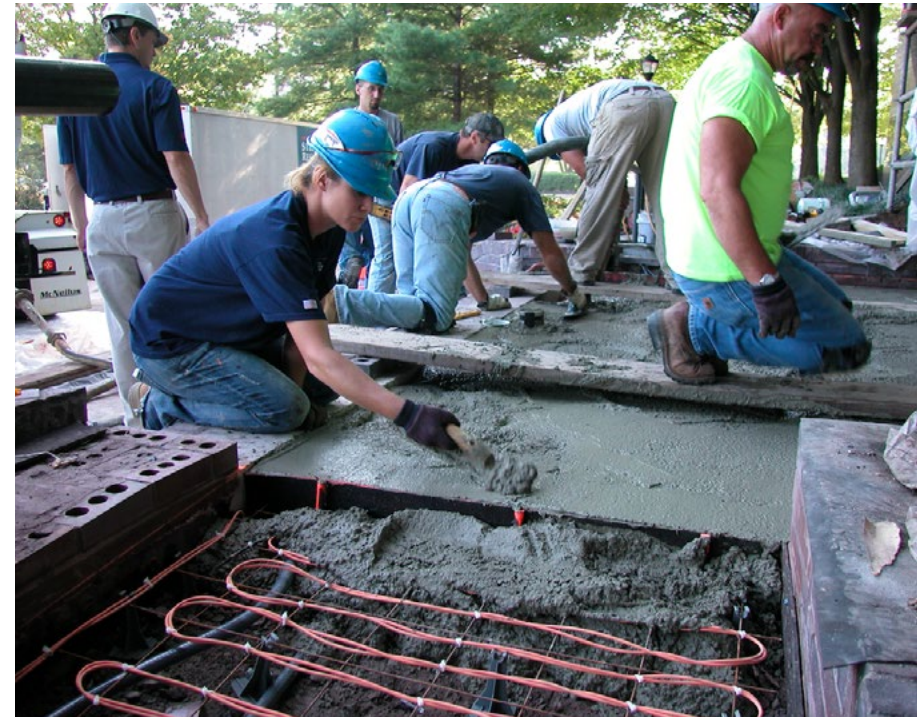
Concrete finishing in progress.

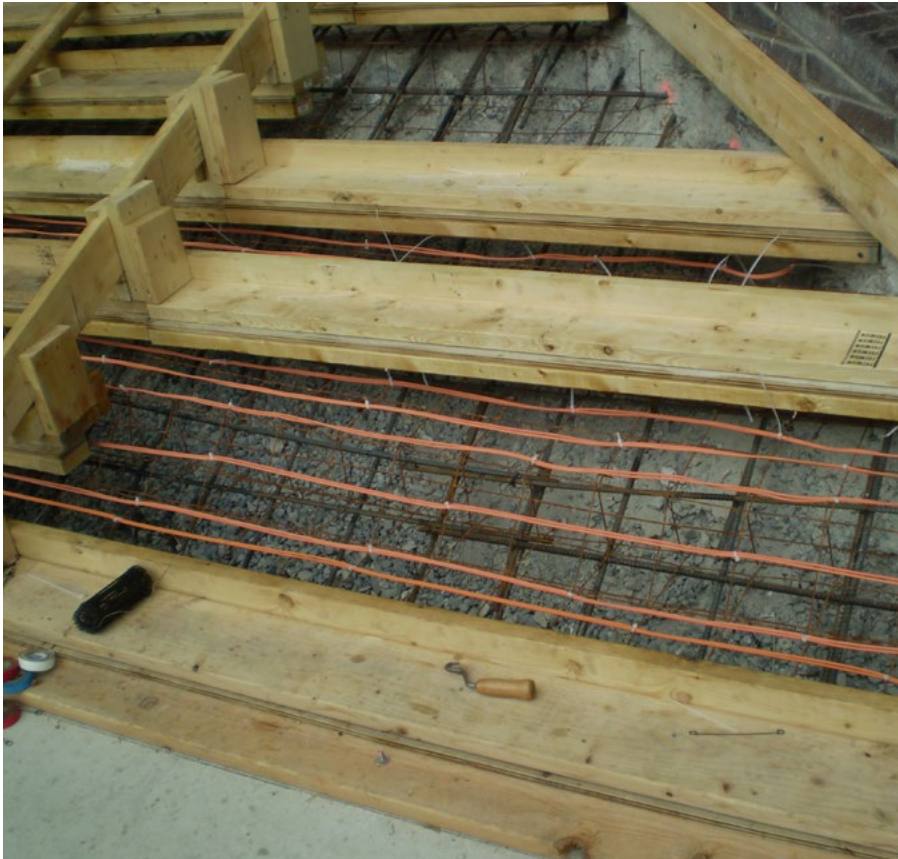
The stairway cables are installed.

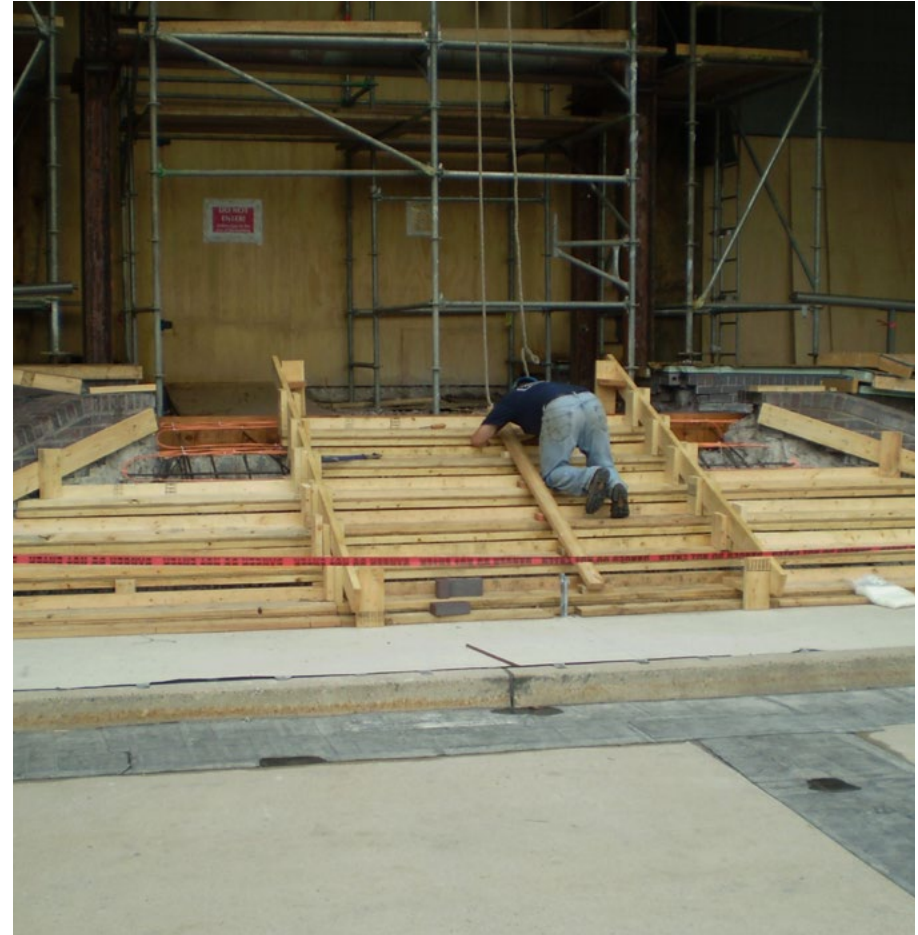
The stairway cables installation.

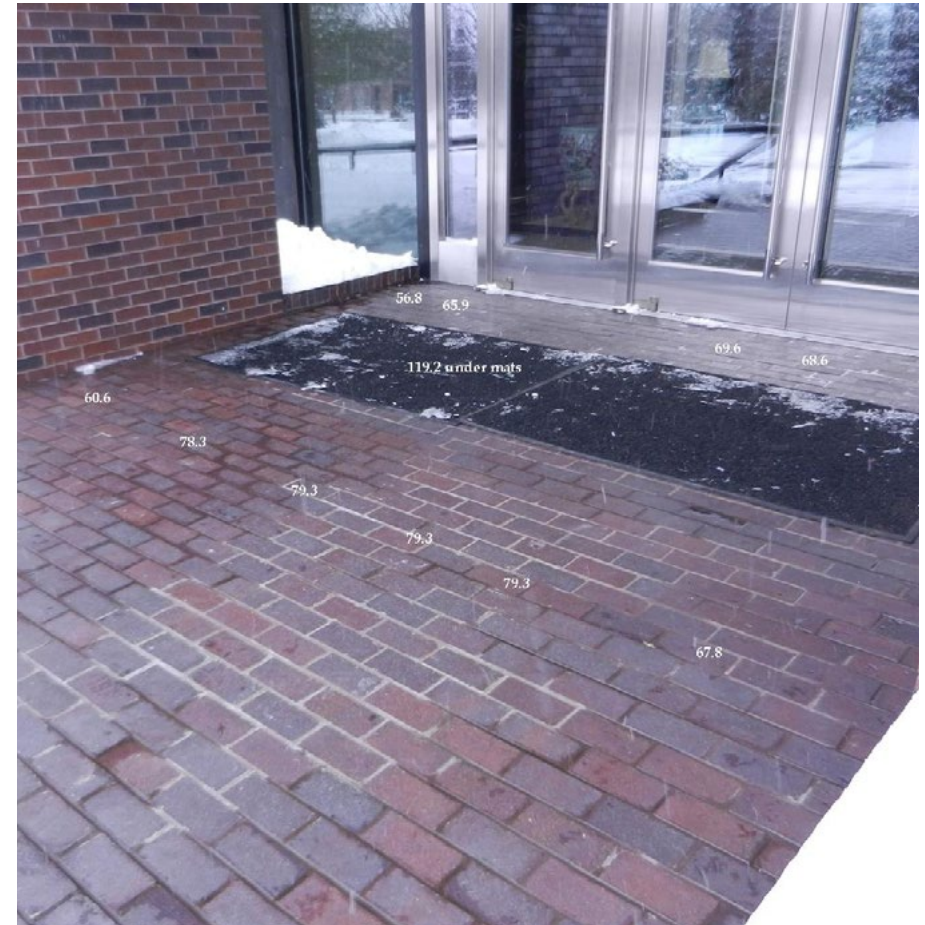
60 amps 277V. The snow melt sensor has three wires required for its separate conduit.

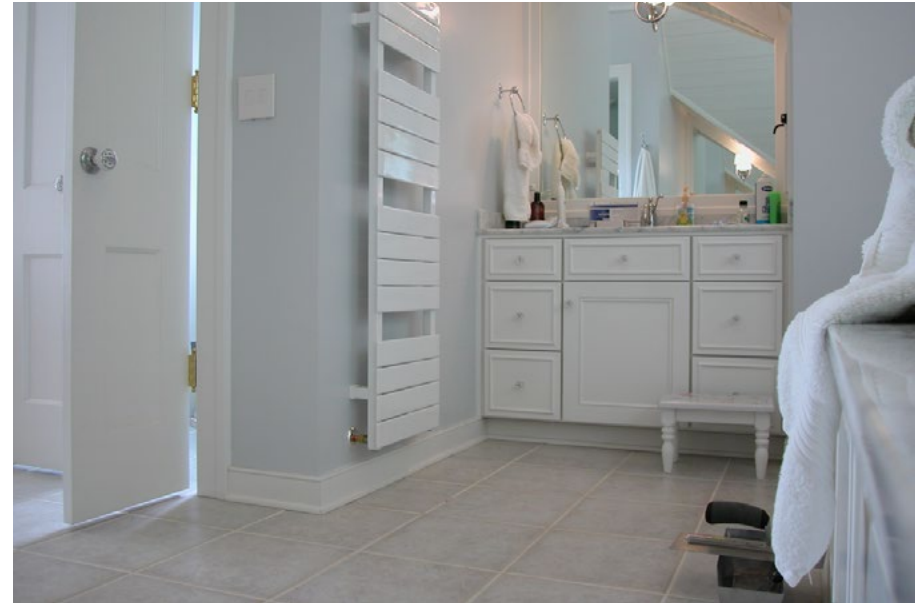
Oversized flat panel radiators are keeping a family toasty warm even in their drafty old farmhouse.

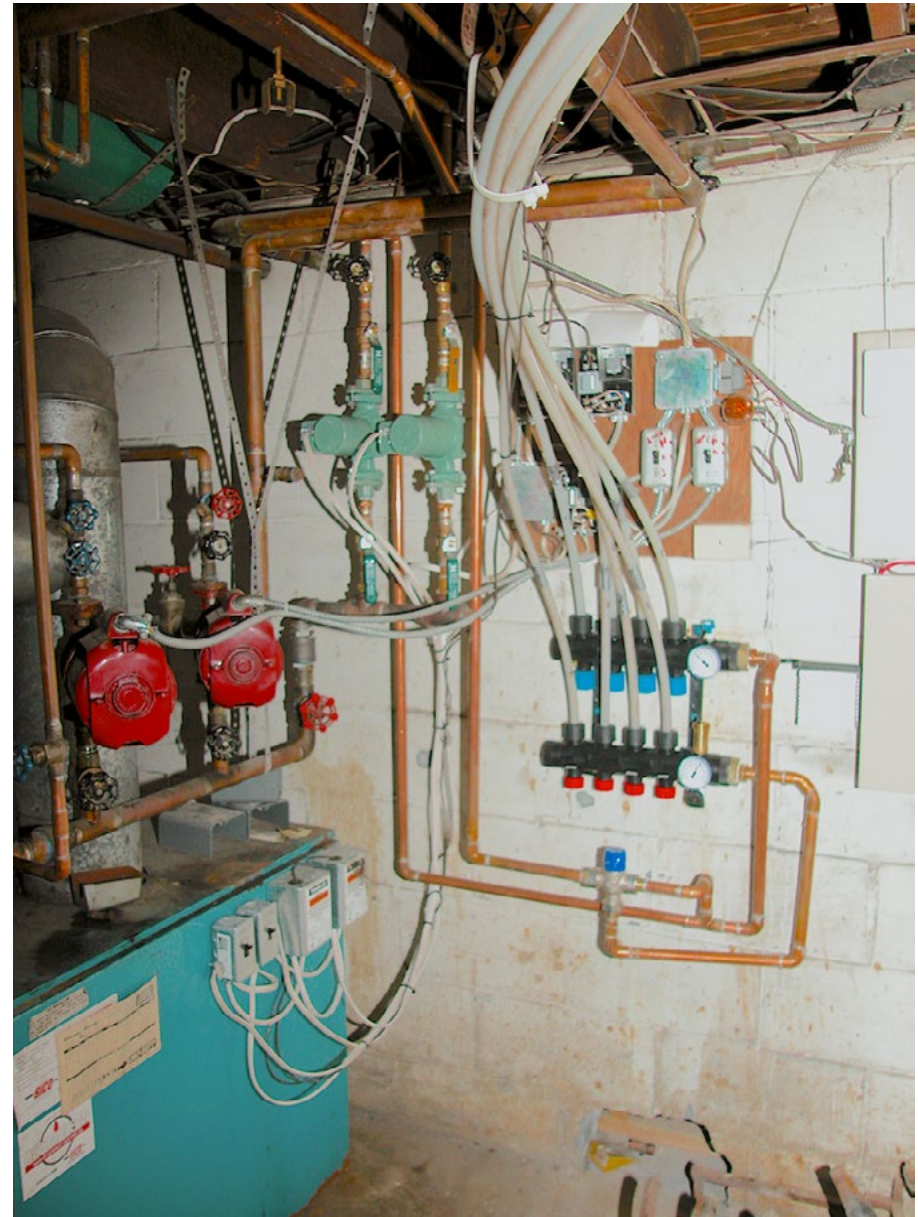
This mechanical room shows lots of room here for dramatic improvement!

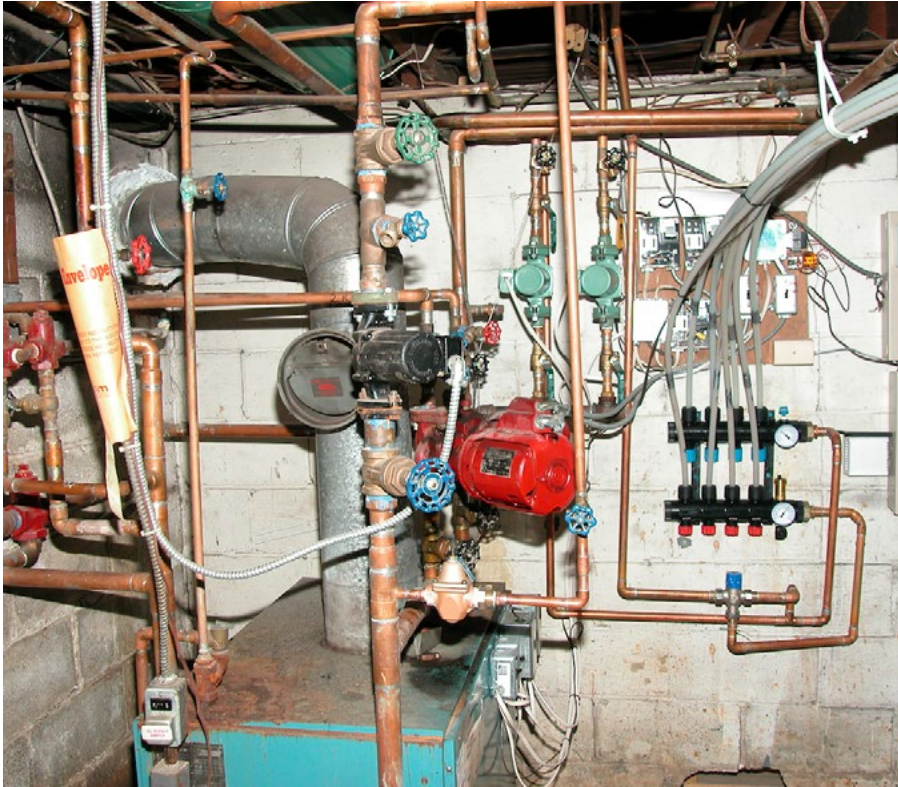
Hydronic mayhem, layer upon layer.

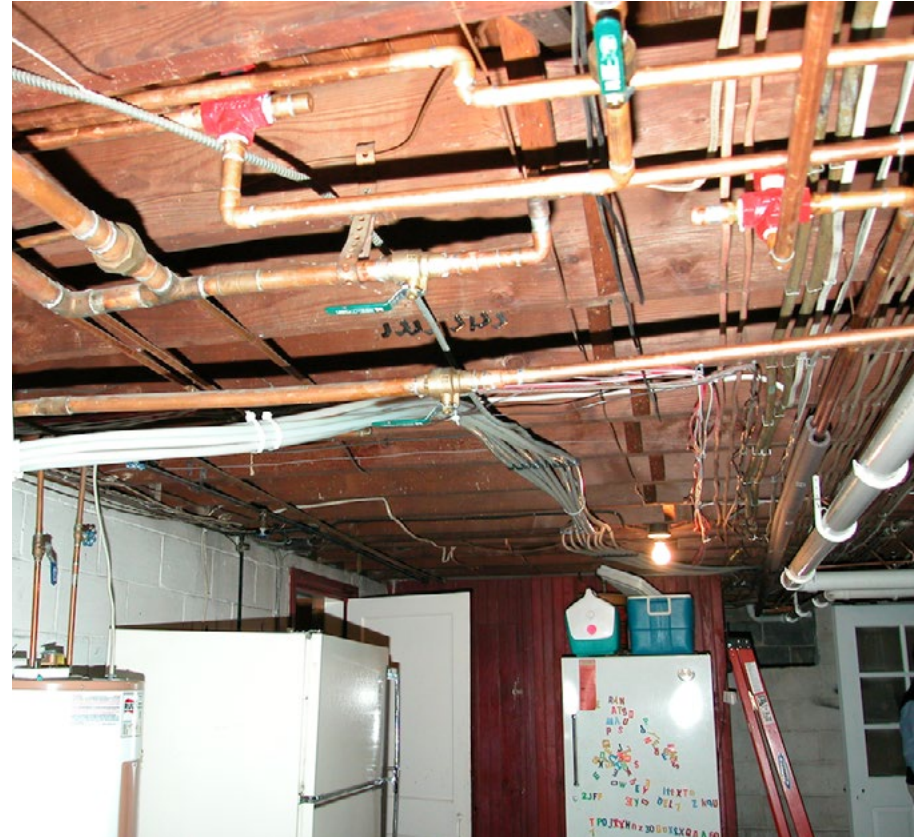
Workmanship lacking: PEX leader lengths are too long, poorly supported and not insulated.
