Glitch & Fix April 2018

Knock On Wood

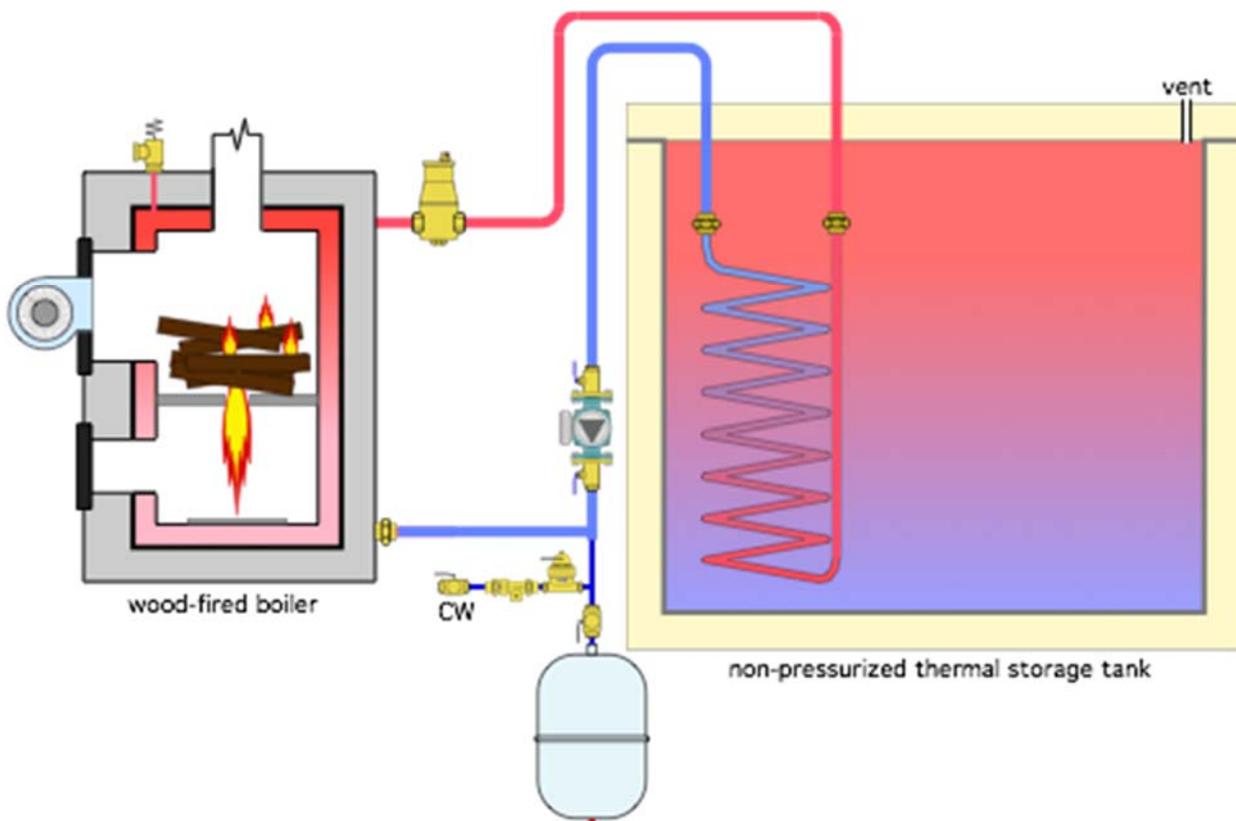
A cordwood gasification boiler gets piped as shown. The boiler has a steel fire tube heat exchanger. The tank is non-pressurized and has a vent hole through the upper lid. The heat extraction portion of the system is not shown. Can you identify at least 5 errors with this configuration.

Here are the shortcomings of the original design:

1. All cordwood gasification boilers require a heat dump that can safely dissipate residual heat from the fire if a power outage occurs. A passive heat dump is common. It consists of an array of finned-tube installed above the boiler, supplied through a normally open zone valve. The latter opens when power is lost to allow thermosiphon flow between the boiler and finned-tube array.

2. All cordwood gasification boilers are designed to operate without sustained flue gas condensation. Some means of monitoring boiler inlet temperature, and reacting to keep that temperature above a minimum of about 140 °F must be provided. In the fix drawing this is handled by a “loading unit”, which combines a thermostatic mixing valve with a circulator.

3. For best performance, all heat exchangers should be piped so that flow passes through or across them in opposite directions. This is called counterflow. As water in the tank is heated buoyancy forces cause it to rise as shown by the white arc in over the heat exchanger coil. Thus, for counterflow, the hottest water from the boiler should enter the top of the helical portion of the coil.

4. There should always be an air space between the water level in the tank and the underside of the cover. That space is intended to accommodate the increase in volume as the water is heated. As shown, the tank is completely filled with water. When the water is heated it will rise and likely leak out through the vent opening at the top.

5. In the original design the circulator is pumping toward the point where then expansion tank connects to the circuit. Circulators should always pump away from that point.

6. There is no check valve in the circuit to prevent reverse thermosiphon flow when the tank is hot and the boiler cools off. If allowed to occur, reverse thermosiphon flow will dissipate heat from the tank through the boiler and adjacent piping.

7. There is no union on the upper piping connection to the boiler, but there is on the inlet connection. Unions aren't required, but it makes no sense to install one and not the other.

8. Although it may be possible to pass the piping leading to the heat exchanger through the top of the tank, this could complicate lid removal is necessary. It's been to pass piping through the upper sidewall of the tank above the maximum water level.

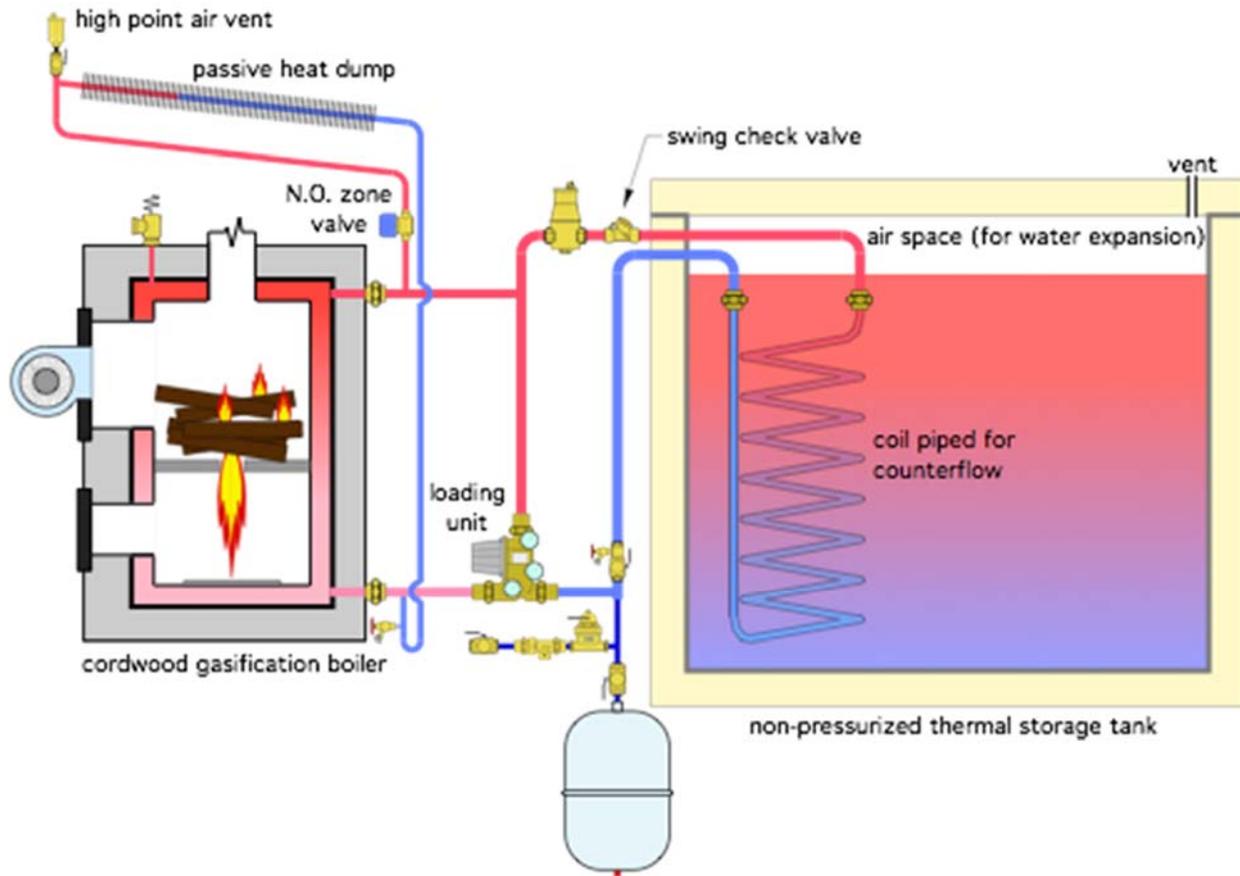
These details have been resolved in the fix drawing below.
